# Synthesis Report on the Application of Temporary Orange Pavement Markings in Work Zones

One recent focus for the committee is the application of temporary orange pavement markings in work zones, an experimental technique per the Manual on Uniform Traffic Control Devices (MUTCD). To assess orange pavement marking practices, ATSSA created a task force focused on this innovation. Seven state departments of transportation (DOTs) have applied orange pavement markings in various configurations to improve work zone safety for the traveling public.

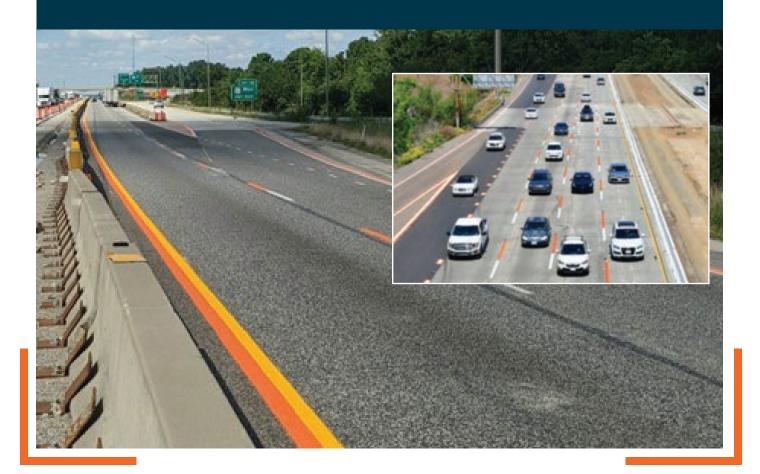
Figure 1. WSDOT Orange Marking Configuration

Project Summary
Location:	Interstate 5 (City of Fife)
Cross Section:	10-lane freeway with one high
	occupancy vehicle lane each way
Material Used:	15 mil Sherwin Williams
	waterborne paint
Configuration:	Lane line skip contrast markings
	(white preceding orange)
Timeline:	March 2023 – Fall 2023
Metrics:	Marking conspicuity, vehicle
	speeds, reported crashes, observed
	driver behavior, intrusions,
	community perceptions

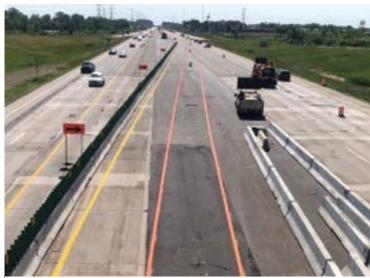
Figure 4. Lane Shift Pavement Markings on Interstate 96

The yellow edge line remained the traditional layout per FHWA requirements, while the skip and white edge lines were replaced with orange markings. In addition, MDOT added orange markings to shifting transition sections at crossovers. The markings were placed in mid-June of 2022 and

Project Summary			
Location:	Interstate 96		
Cross Section:	4-lane freeway		
Material Used:	Waterborne paint		
Configuration:	6-inch lane line and orange		
	edge line markings at 22 mils		
Timeline:	2022 (Summer)		
Metrics:	Retroreflectivity of markings

removed at the end of October of 2022. While evaluation results are still being developed, MDOT captured initial retroreflective readings between 350 and 420 millicandelas per square meter per lux. By the end of the project, readings were between 60 and 100. MDOT developed a proposal for machine vision data collection on the approaches with orange lane lines and edge lines. As vehicles approach the shift, dashed lines turn to solid orange 300 feet prior to the transition to discourage lane changing or passing. Within the shifting taper, MDOT will evaluate the lateral movement based on the detection of orange markings. In the tangent section, the orange markings remain solid throughout the remainder of the area. This will allow assessment of lane tracking and positioning after the transition. Initial reports from the automotive companies showed no differences in reading the orange versus yellow and in some cases the systems read the orange as red in color. A full report will be released in 2023.

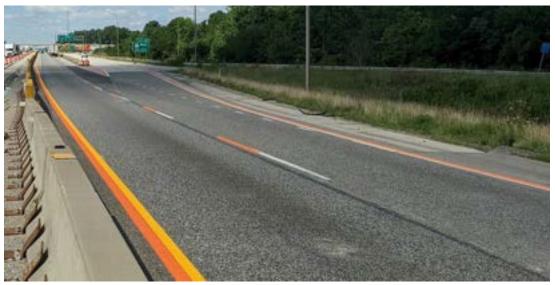
Figure 6. Supplemental Orange Markings on Interstate 65 Northbound

supplemented traditional white and yellow markings with orange contrast markings on the lane line (white preceding orange) and adjacent to (outside) each edge line. INDOT used the supplemental markings to address a specific safety issue at this location.

INDOT commissioned an evaluation of the test project using a brief public perception questionnaire with flyers placed at a rest area near the project site. Of 53 respondents, 88% reported they noticed the orange pavement markings in the work zone and 80% reported the markings made them more aware of the presence of the work zone. In addition, 81% and 82% of the respondents felt the orange markings were more visible than white markings and yellow markings, respectively.
