# Assessing Pavement Markings for Automated Vehicle Readiness

**Adam Pike, Principal Investigator**  
Texas A&M Transportation Institute

Research Project  
Final Report 2024-16

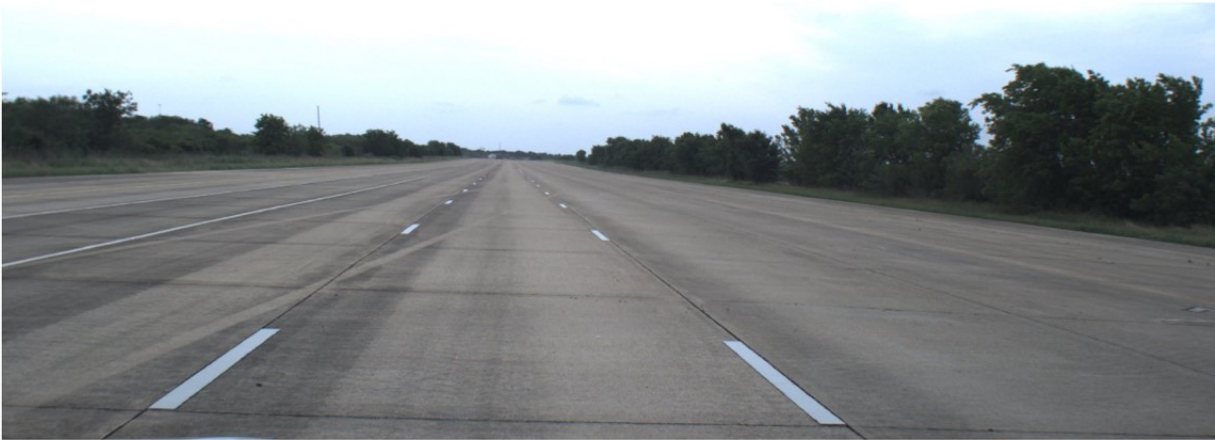
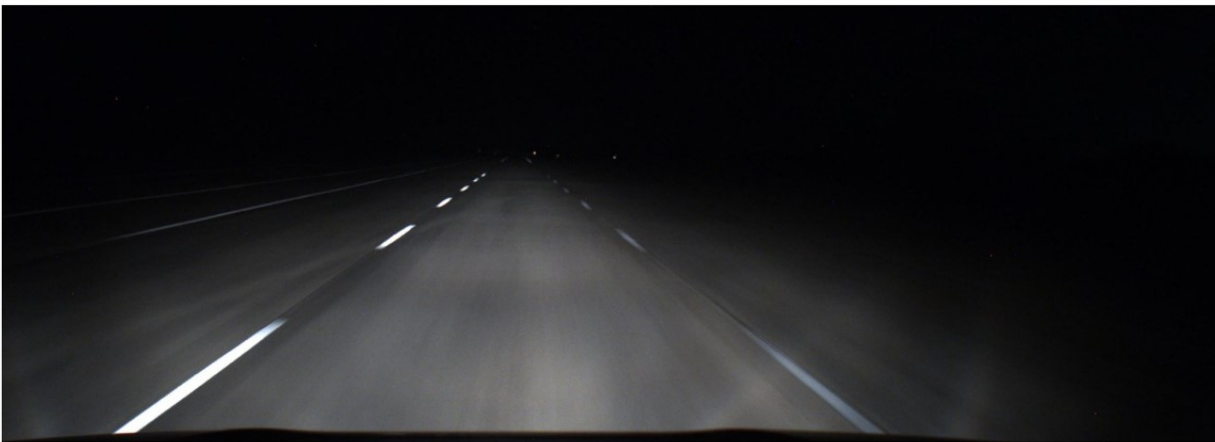
**Figure 2. Images of 10-40 gap pavement markings (Set 2: 06W-6 on left and 02W-6 on right) during day (above) and (Set 2: 08W on left and 01W on right) at night (below)**

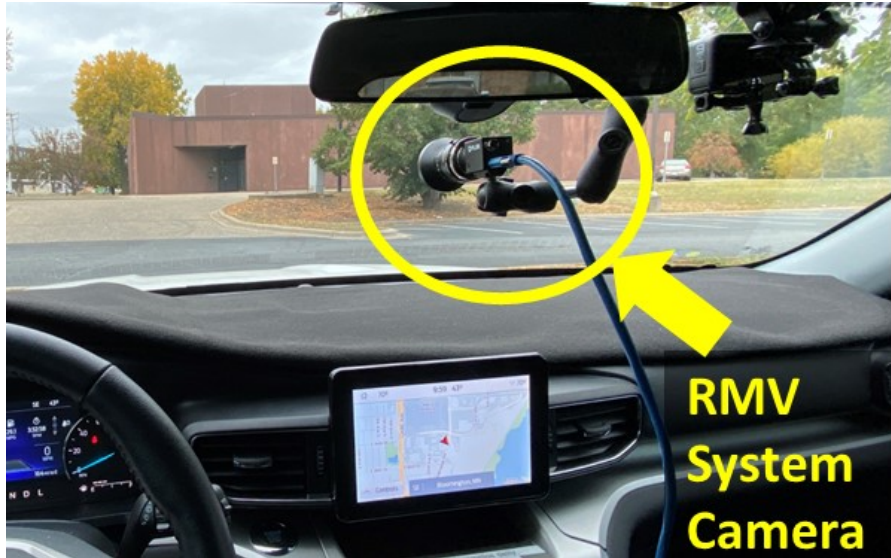
markings. It is anticipated that better markings will result in higher levels of agreement between the marking tracking by the lane tracking algorithm and the annotated locations. The system is used to generate quantitative data on tracking markings and serves as an alternative to being able to collect data with actual advanced driver assist systems in vehicles. Figure 3 shows the RMV system camera installed in the test vehicle.

**Figure 3. TTI/TAMU RMV system.**

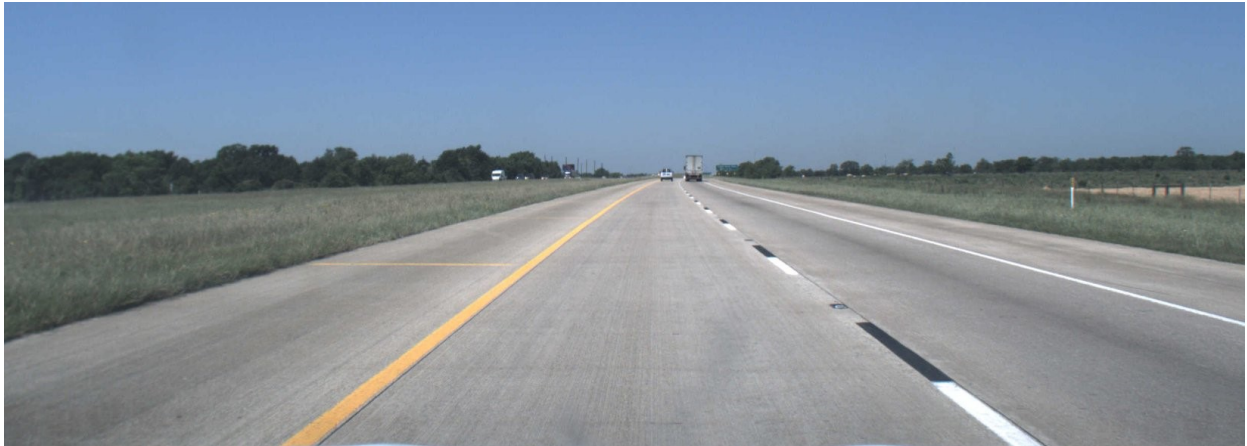
Figure 4. Image of a road segment with white pavement marking followed by black (driving westbound).

1. White pavement marking followed by black (WB) [Figure 4, Figure 5]
2. White pavement markings with a black border (BWB) [Figure 6, Figure 7]
3. Combination of 4-inch and 6-inch-wide white markings (White)

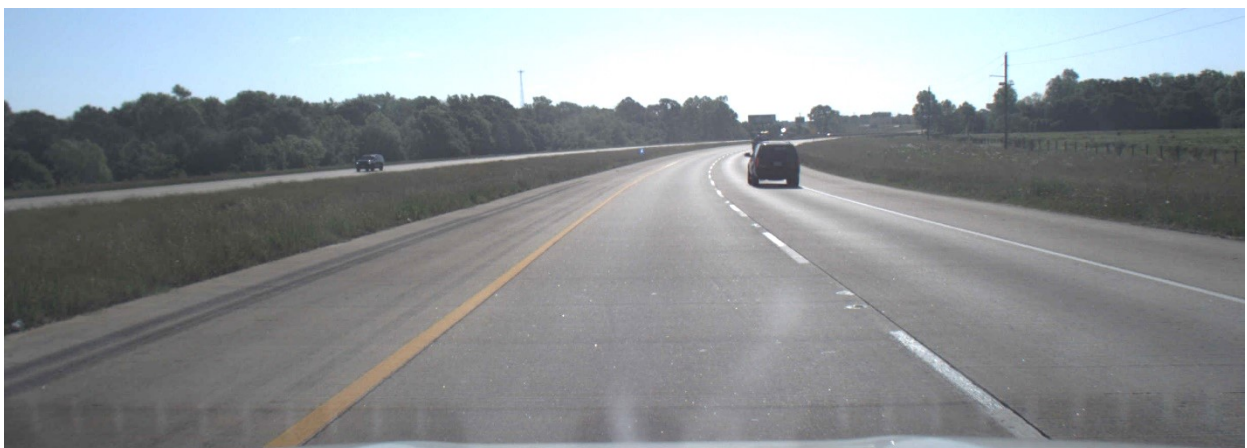
Figure 5. Image of a road segment with white pavement marking followed by black (driving eastbound).

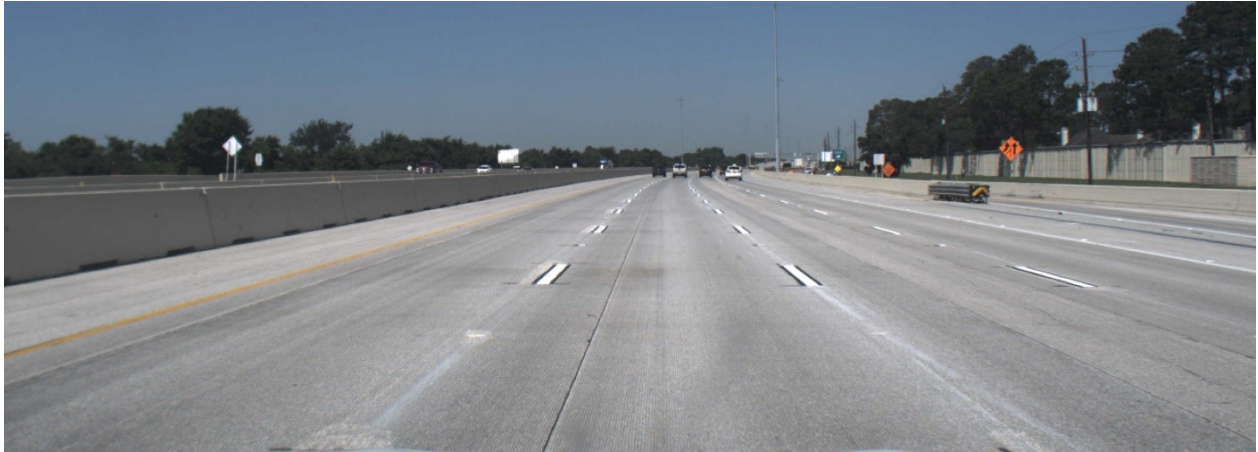
Figure 6. Image of a road segment with white pavement markings with a black border (driving westbound).

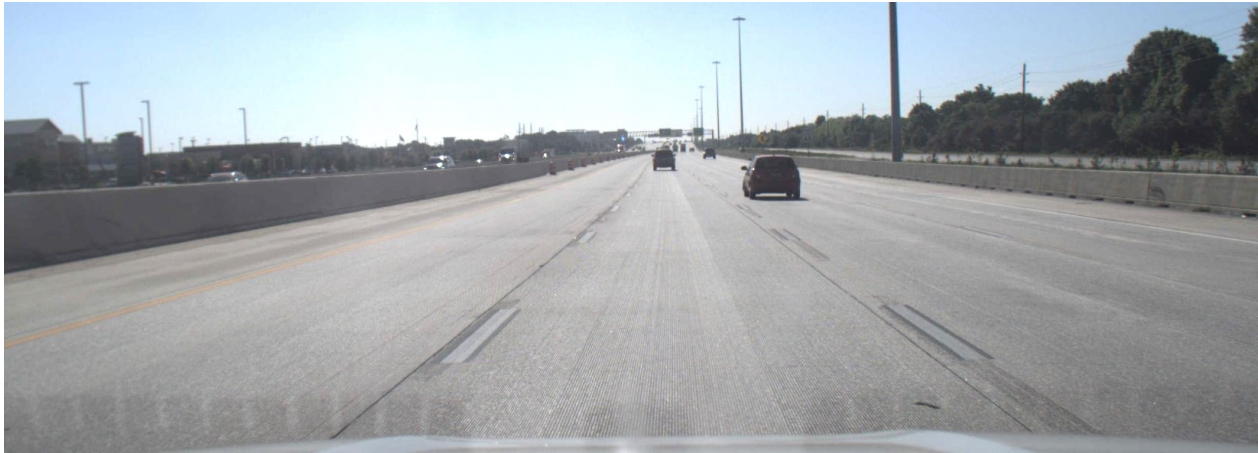
Figure 7. Image of a road segment with white pavement markings with a black border (driving eastbound).

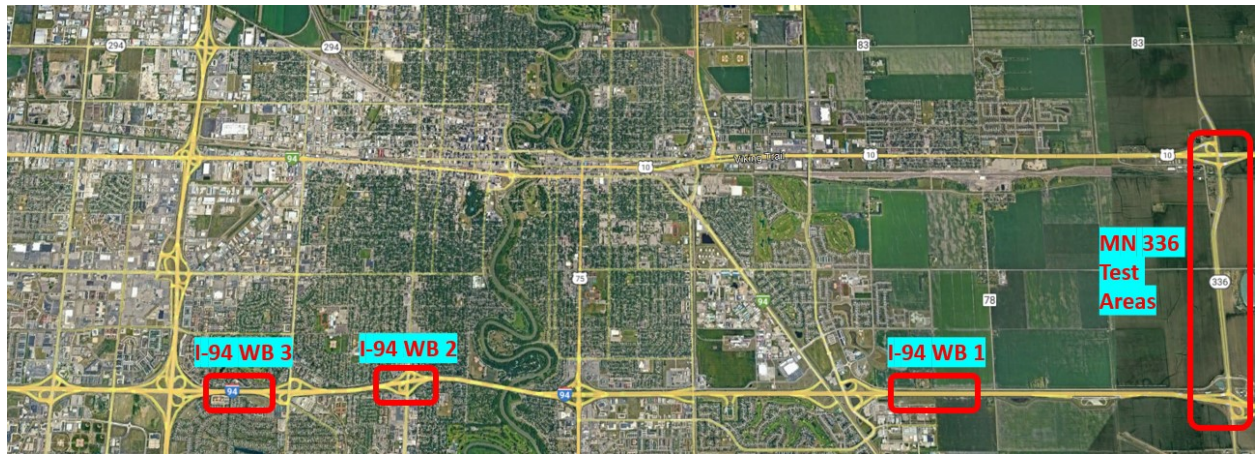
**Figure 8. Test area layout.**

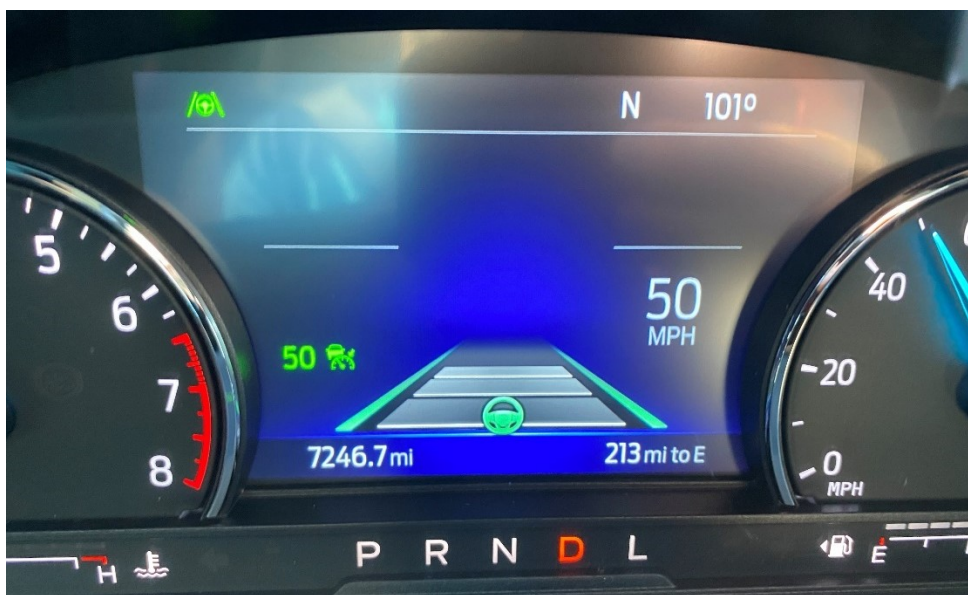
The research team used a 2022 Ford Explorer with a Co-Pilot 360 Assist+ system to evaluate the markings. Figure 20 shows the OEM camera used for the Co-Pilot 360 Assist+ system. The Co-Pilot 360 Assist+ system provides lane centering capability when the system is active and the markings are able to be tracked. The vehicle operator maintained a light touch on the steering wheel to keep the system active but allowed the vehicle to provide the steering during testing. The research team used two GoPro cameras to record the forward scene and the instrument cluster. The instrument cluster indicated when the system was active and if lane centering functions were working. Figure 22 shows the instrument cluster with the Co-Pilot 360 Assist+ system active and tracking the markings. The system is active and tracking the markings when the lines are green. The lines are gray when it is not tracking.

Figure 22. Ford Co-Pilot 360 Assist+ gauge cluster.

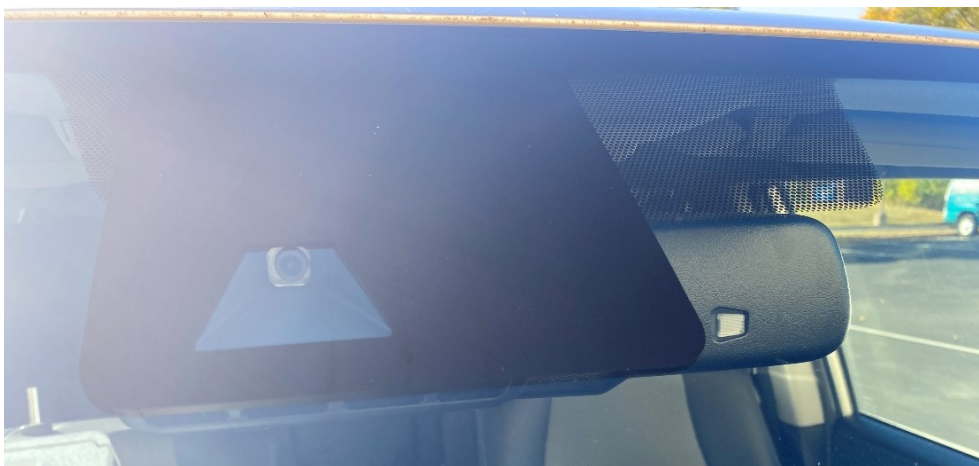
The research team used a 2022 Toyota 4Runner to evaluate most of the pavement marking test areas. The 4Runner has a lower level of ADAS compared to other test vehicles. The 4Runner uses a single forward-facing camera as displayed in Figure 27. The evaluated system only provides lane departure warning when the system senses the vehicle leaving the lane. Figure 28 provides several images of the 4Runner instrument gauge cluster. The top image shows the lane departure warning system when no markings are being tracked as indicated by the empty lines. The middle image shows the system when it is tracking markings on both sides of the vehicle as indicated with the filled in white lines. The bottom image shows the system when the warning is being provided for a lane departure with the orange line. When operating the vehicle the operator maintained steering of the vehicle but allowed the vehicle to encroach on markings to test when the system would sense a lane departure. An interior video camera was used to monitor the vehicle steering as it proceeded through the test areas.

Figure 27. Toyota forward facing camera.

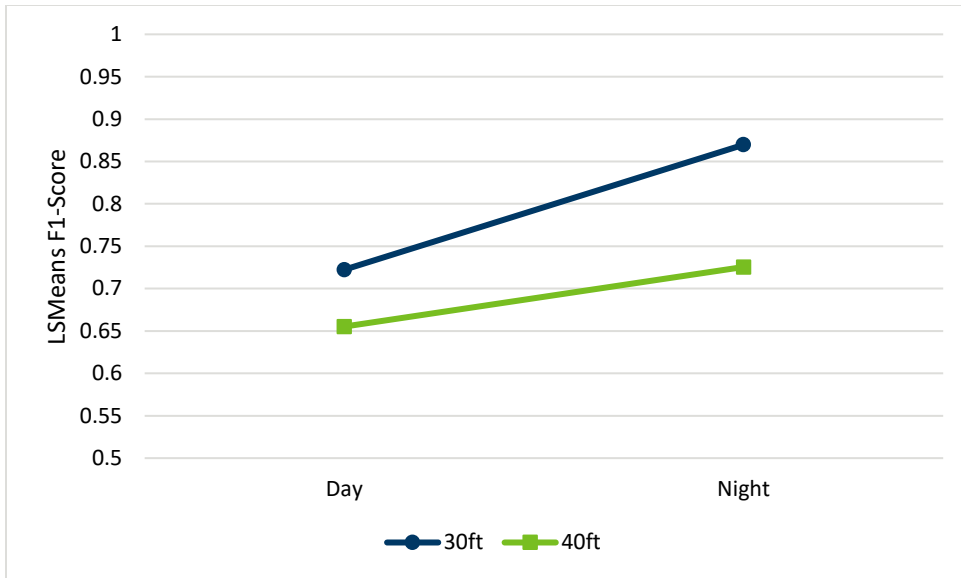
Figure 29 shows that LD performance was higher for the 10-30 configuration as compared to 10-40 configuration during both day and night. This is likely due to the fact that closer lane markings result in more marking for the LD algorithms to detect, leading to higher LD performance. Table 10 lists the least square mean value of F1 scores output for the different spacing configurations. Figure 30 and Figure 31 provide the results of the 2-way interaction of spacing and marking material for LD performance during daytime and nighttime respectively.

Figure 29. Effect of marking spacing and lighting condition on LD performance.

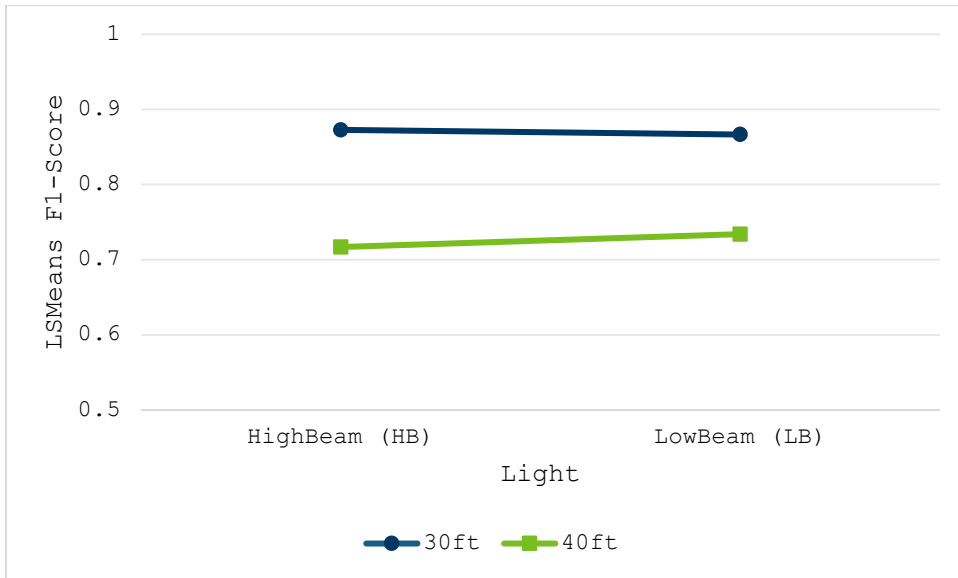
Figure 32. Effect of nighttime illumination on LD performance.

Table 11 shows the least square means table comparing the effect of nighttime illumination on LD performance. The performance difference between high and low beam is negligible.

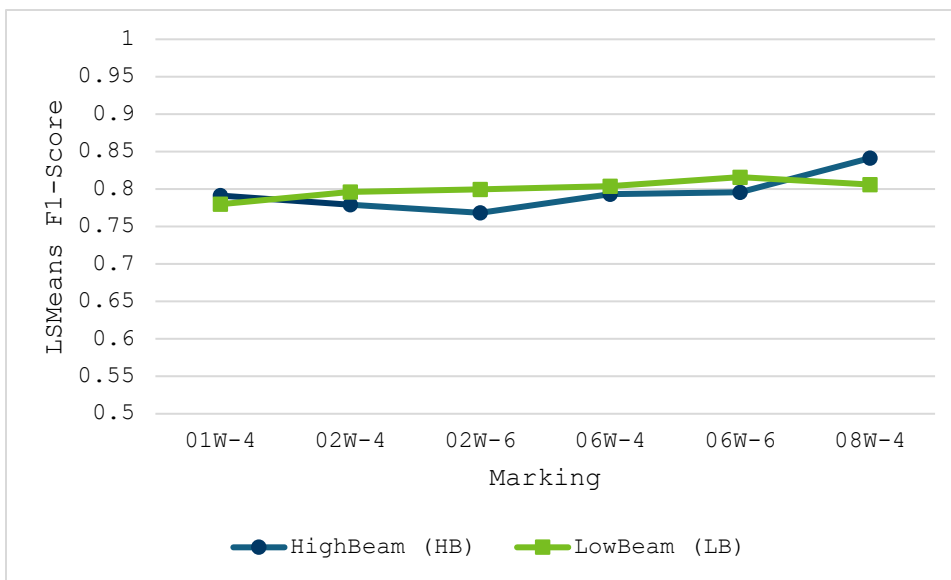
Figure 33. Effect of two-way interaction of nighttime illumination on marking material for LD performance.

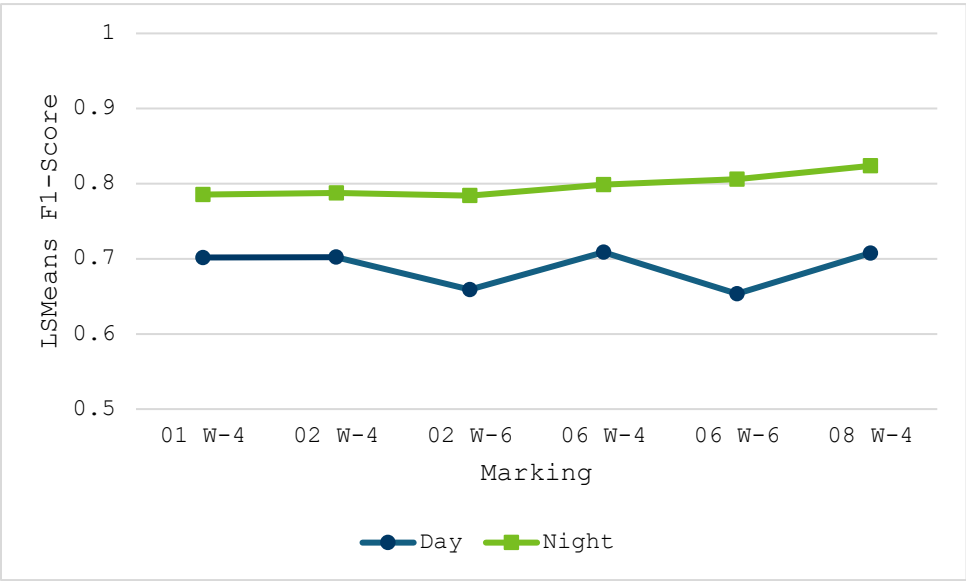
Figure 34. Effect of marking material for LD performance.

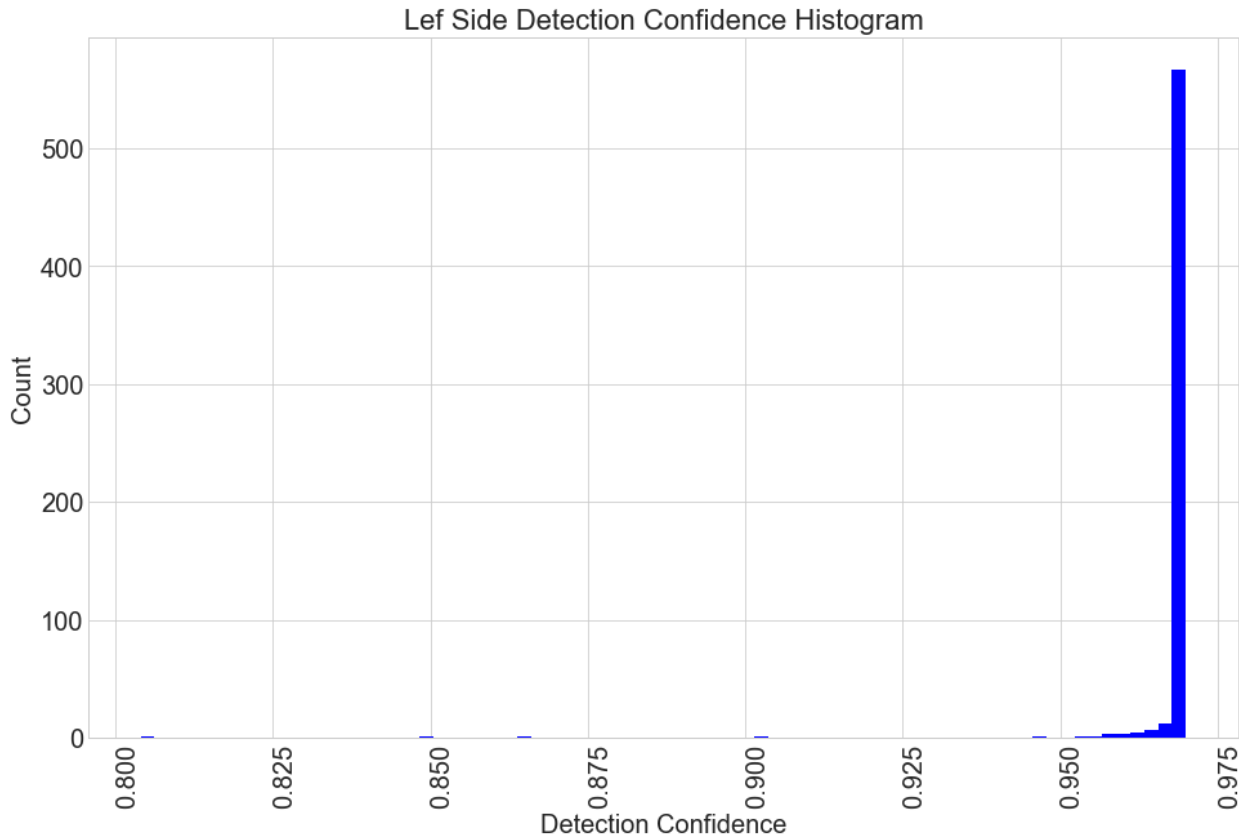
The study team observed that the data for all segments were highly skewed with the majority of values being 0.96 and 0.97. Figure 36 shows the histogram of left side detection confidence values.

**Figure 36. Left side detection confidence histogram.**

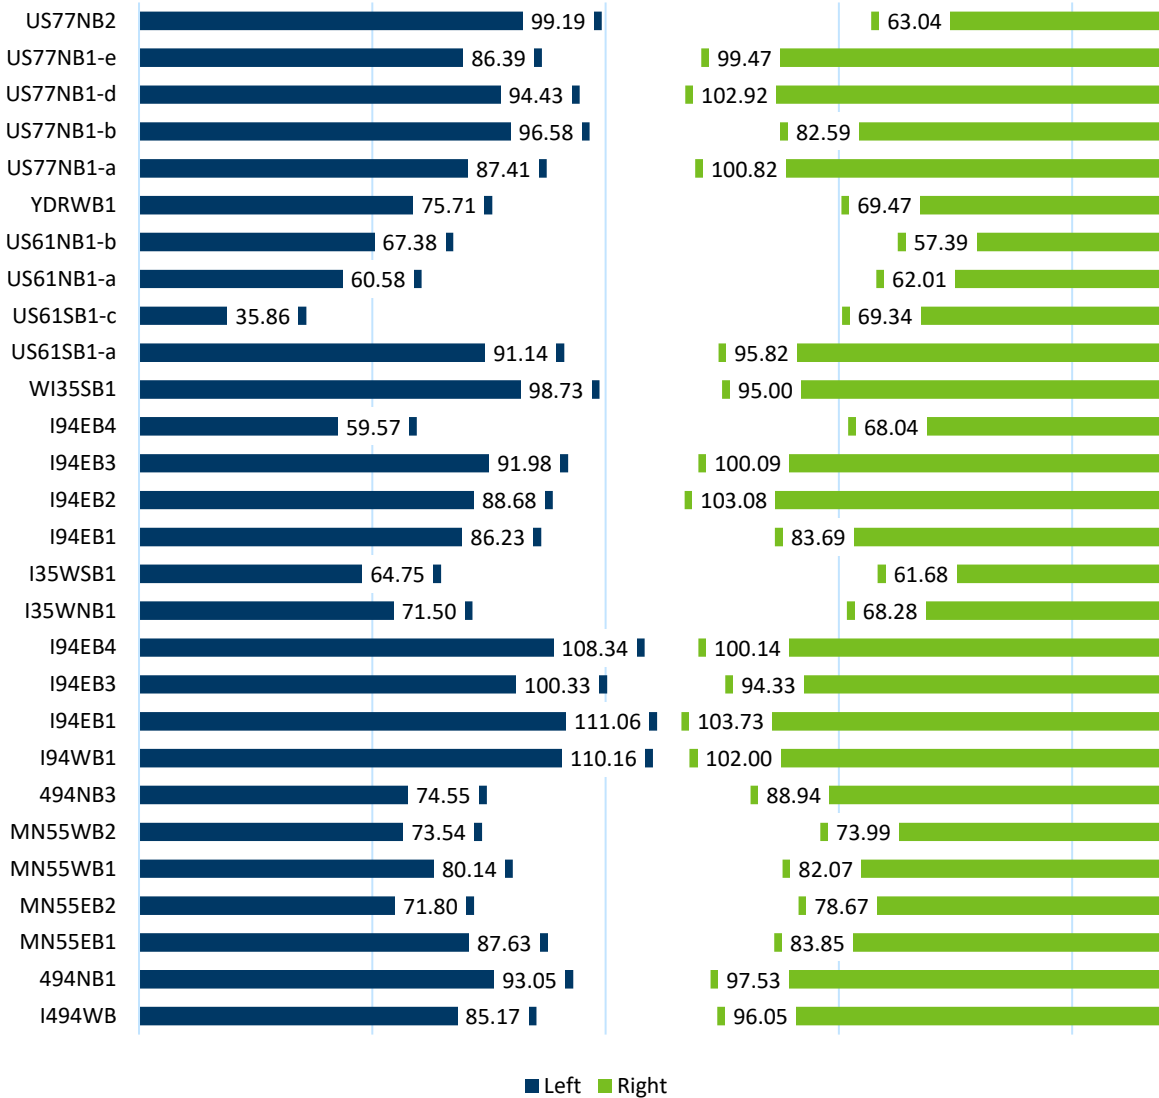
Figure 80. End of line values for left and right pavement markings during the day.

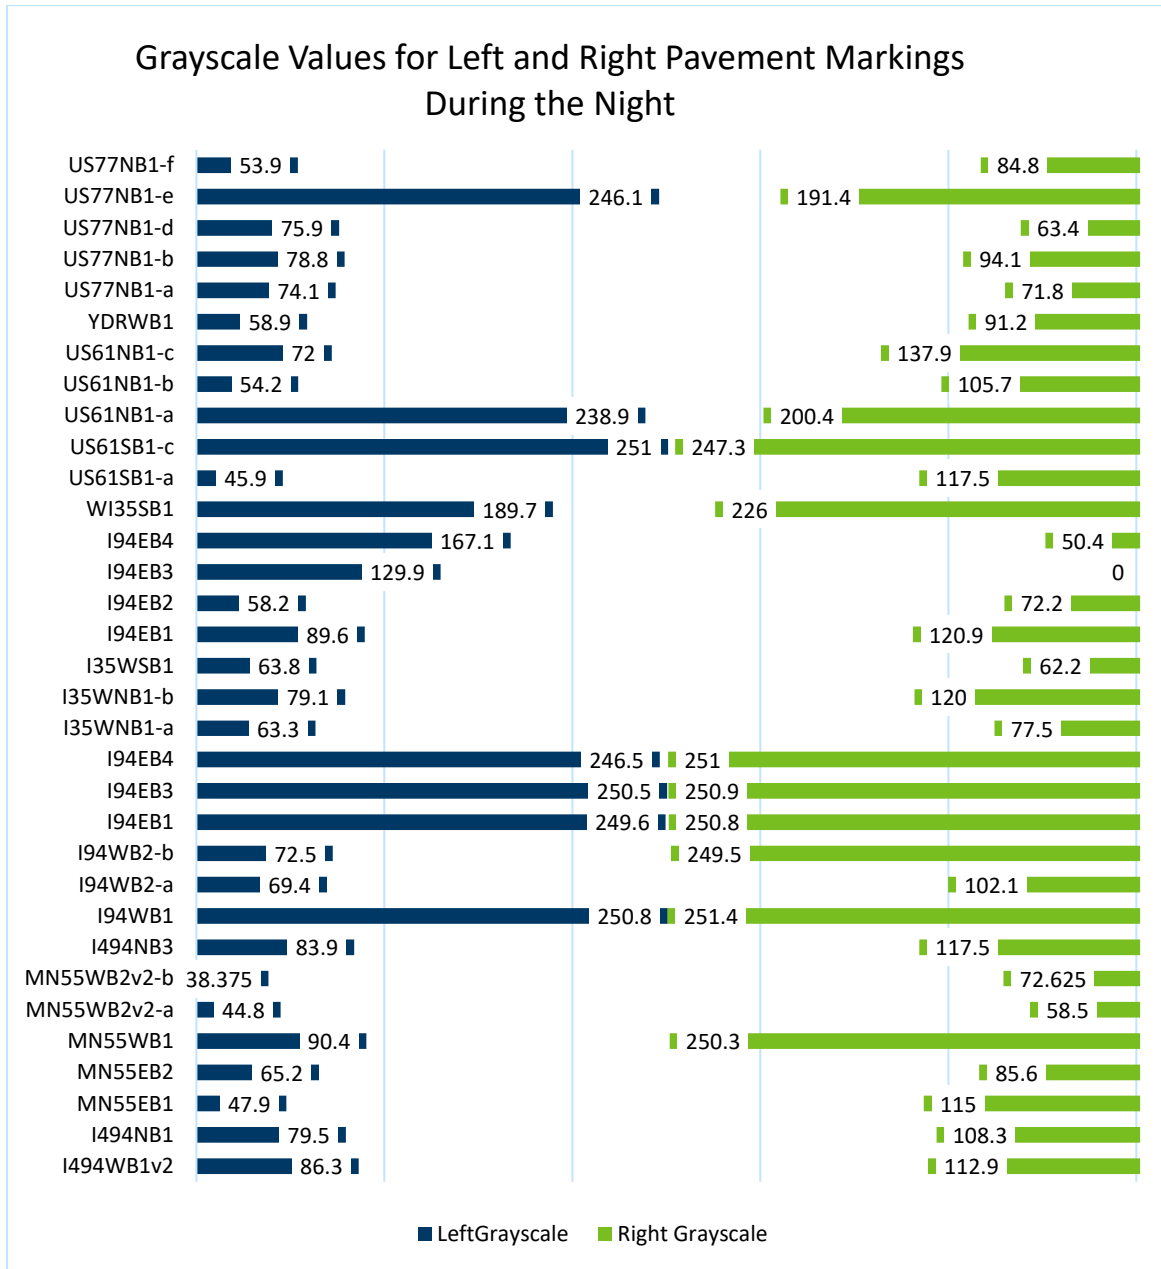
Figure 83. Grayscale values for left and right pavement markings during the night.

Table 27 and fit statistics of the model are shown in Table 28. We can see that Grayscale is not a significant variable to predict detection confidence. This is likely due to the majority of the sections having high detection confidence regardless of the grayscale value.

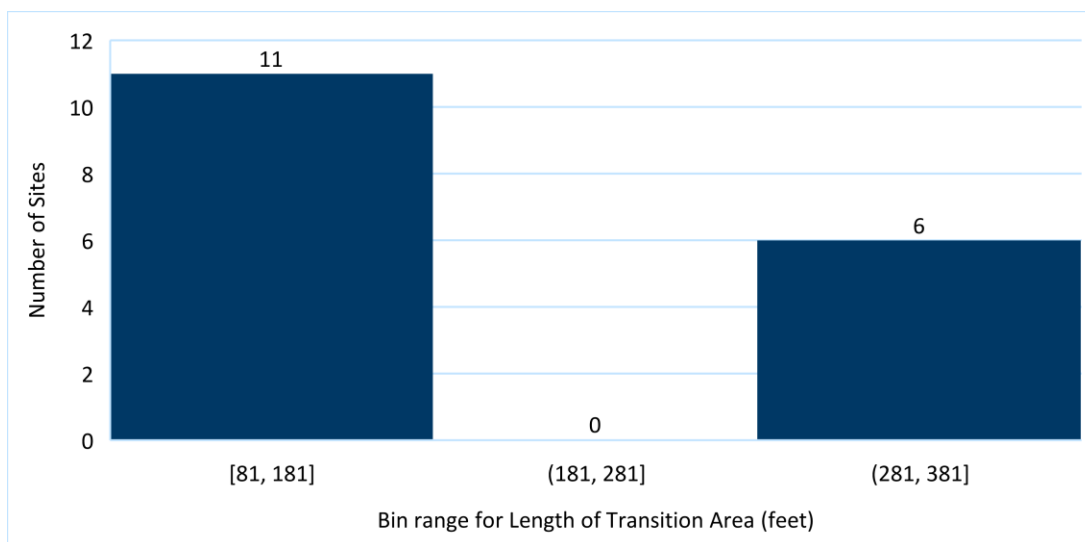
**Figure 88. Transition segment length distribution for left turn lanes.**

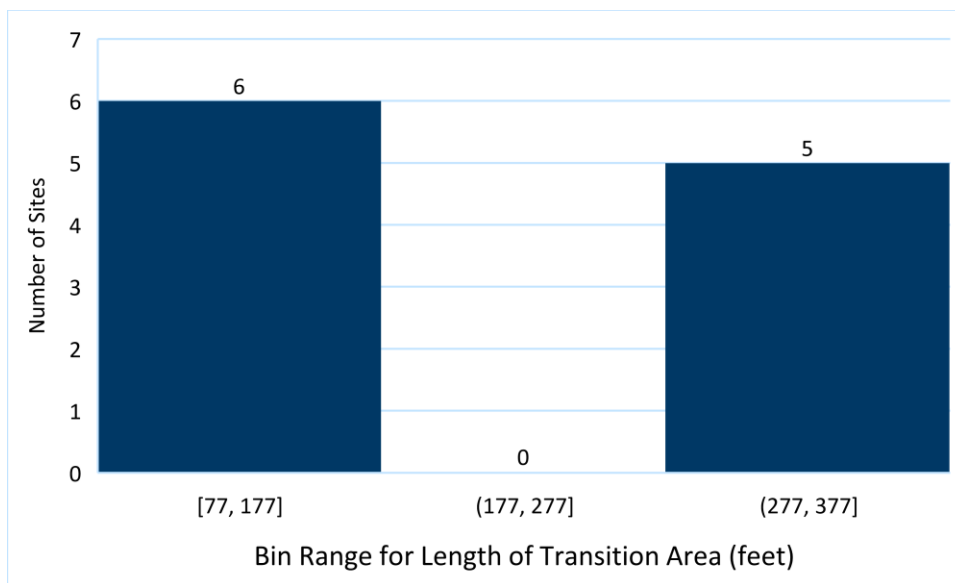
**Figure 89. Transition segment length distribution for off ramp locations.**
