Assessing Pavement Markings for Automated Vehicle Readiness

June 2024

Research Project
Final Report 2024-16

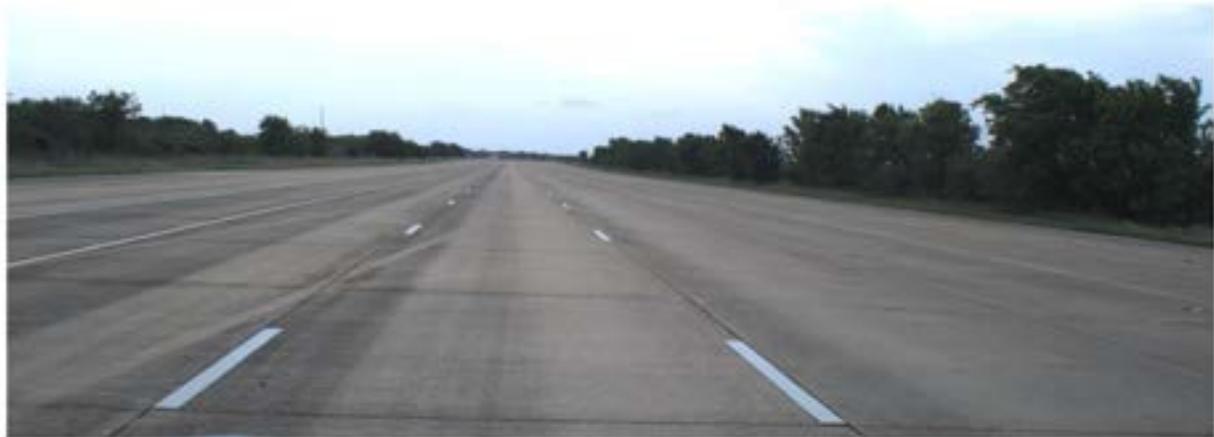
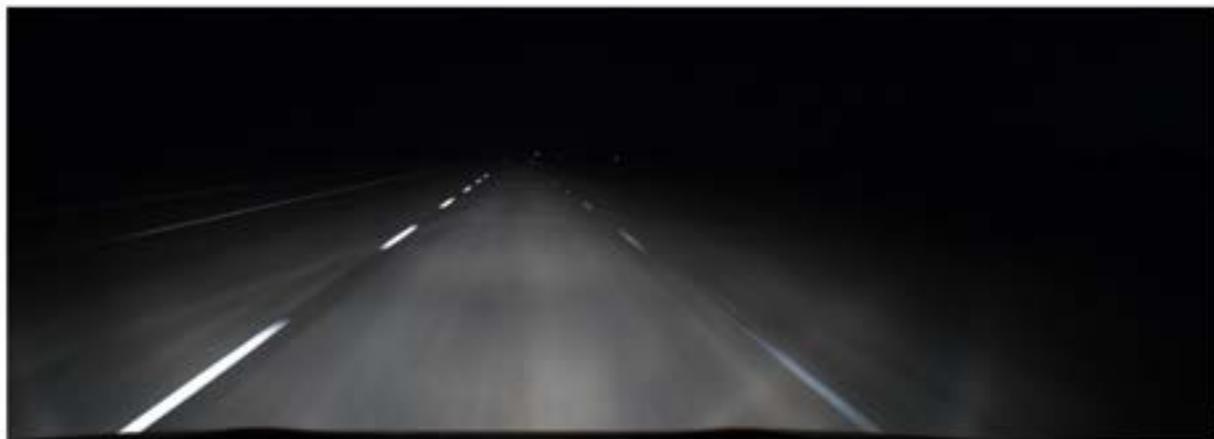
Figure 2. Images of 10-40 gap pavement markings (Set 2: 06W-6 on left and 02W-6 on right) during day (above) and (Set 2: 08W on left and 01W on right) at night (below)

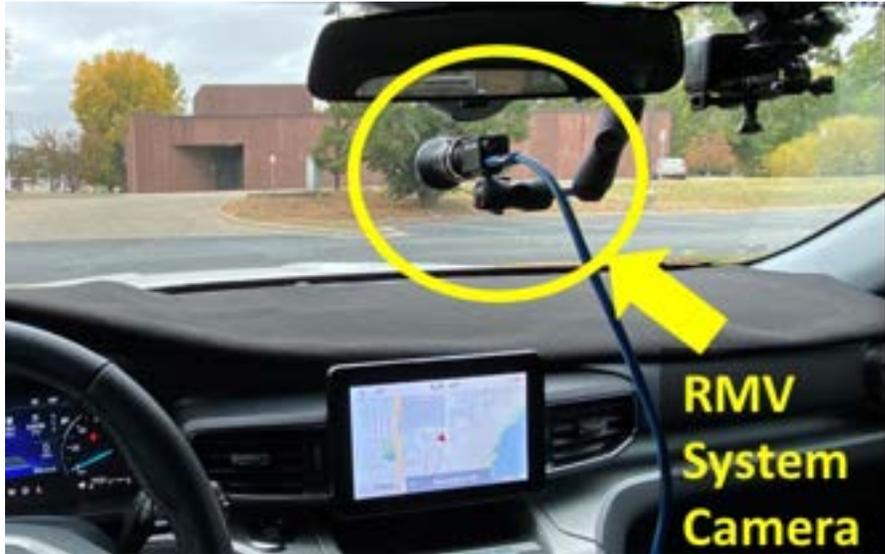
Figure 3. TTI/TAMU RMV system.

Video data were collected using the TTI/TAMU Reference Machine Vision (RMV) system. The RMV system was being developed as part of research project [27], “Reference Machine Vision for ADAS Functions.” With the objectives of this MnDOT project in mind, specific test scenarios were developed to evaluate the impact of changing the markings and to evaluate the function of the RMV system. The RMV system utilizes a forward-facing camera connected to a laptop. The camera is used to collect images of the forward scene that are later processed in image analysis software. The image analysis software is used to annotate the images for the actual location of the markings and then an algorithm that tracks the markings is run on the image set. The difference between the annotated locations and where the algorithm thinks the markings are located is used to calculate how well the algorithm tracks the

markings. It is anticipated that better markings will result in higher levels of agreement between the marking tracking by the lane tracking algorithm and the annotated locations. The system is used to generate quantitative data on tracking markings and serves as an alternative to being able to collect data with actual advanced driver assist systems in vehicles. Figure 3 shows the RMV system camera installed in the test vehicle.

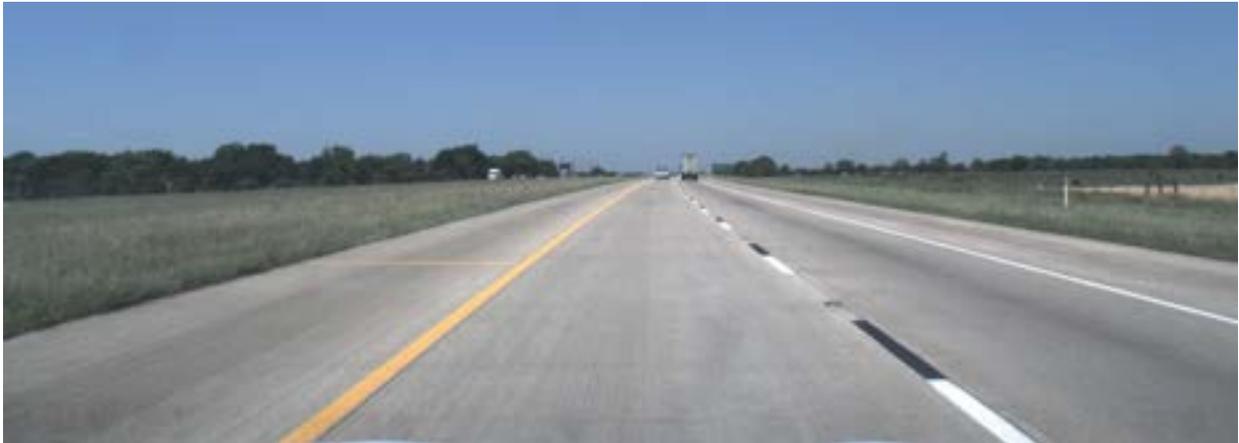
Figure 4. Image of a road segment with white pavement marking followed by black (driving westbound).

1. White pavement marking followed by black (WB) [Figure 4, Figure 5]
2. White pavement markings with a black border (BWB) [Figure 6, Figure 7]
3. Combination of 4-inch and 6-inch-wide white markings (White)

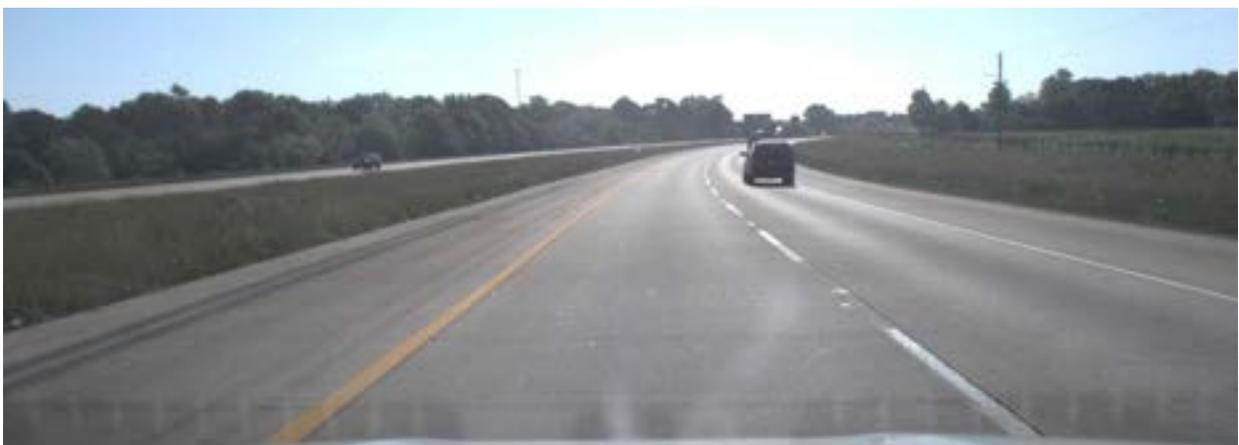
Figure 5. Image of a road segment with white pavement marking followed by black (driving eastbound).

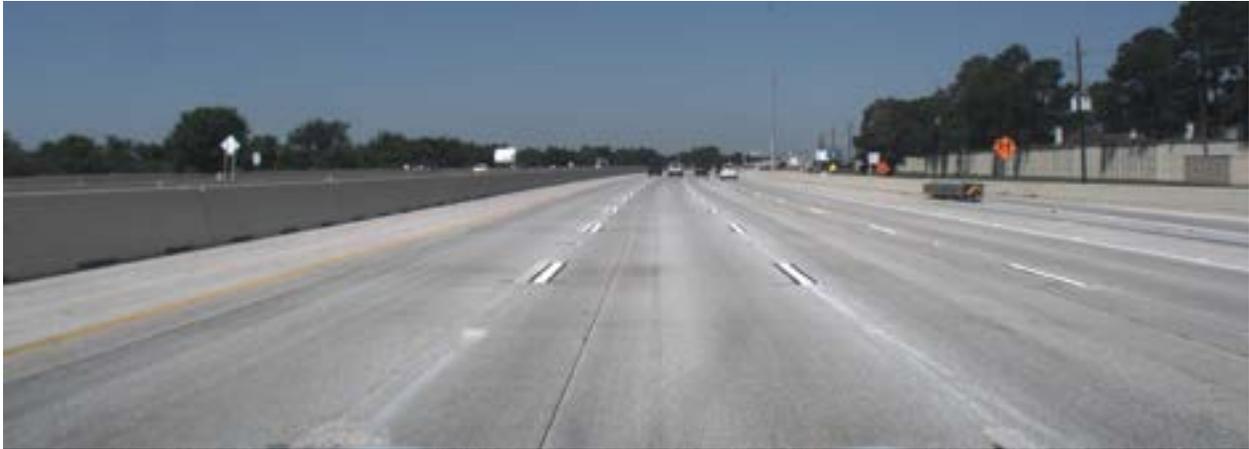
Figure 6. Image of a road segment with white pavement markings with a black border (driving westbound).

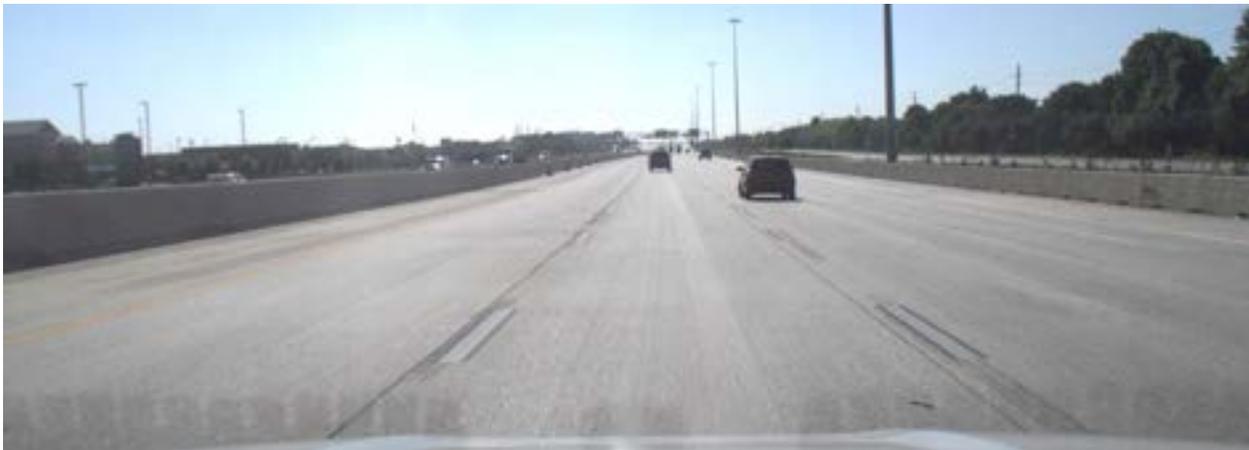
Figure 7. Image of a road segment with white pavement markings with a black border (driving eastbound).

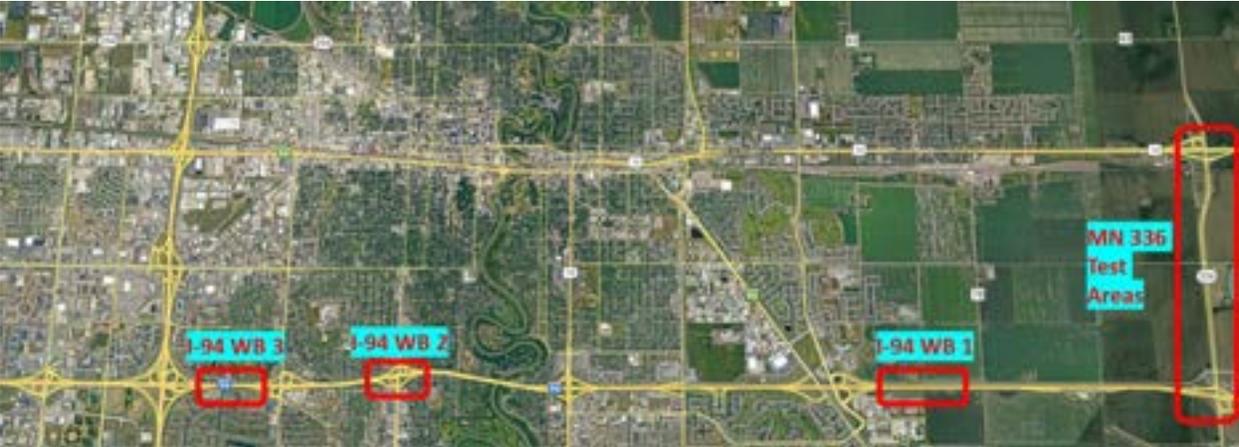
Figure 8. Test area layout.

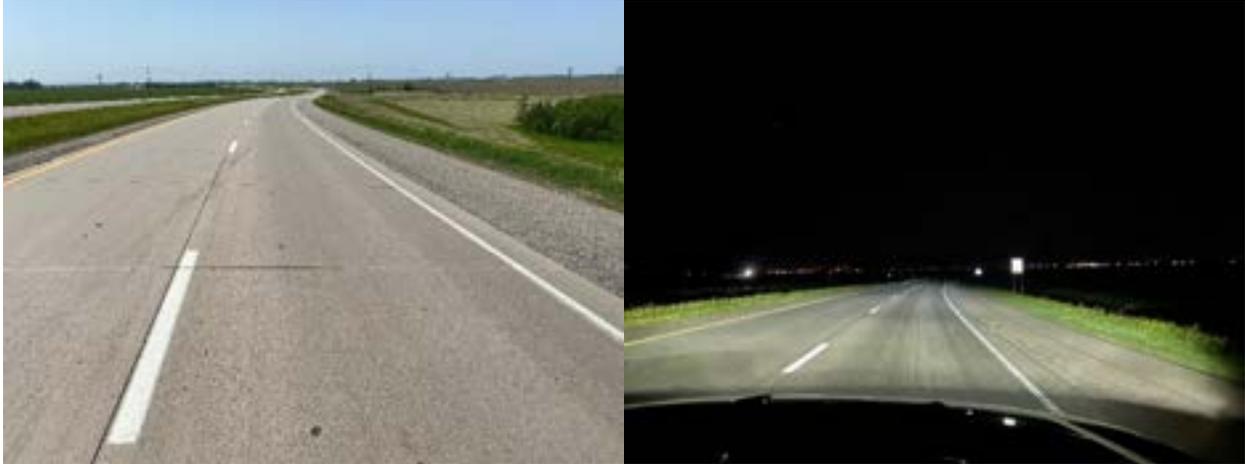
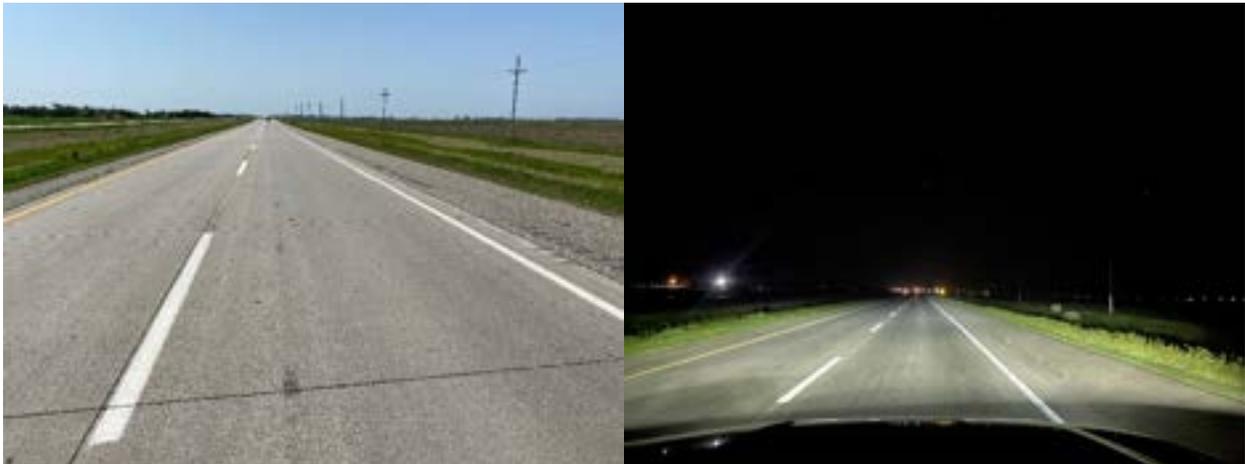
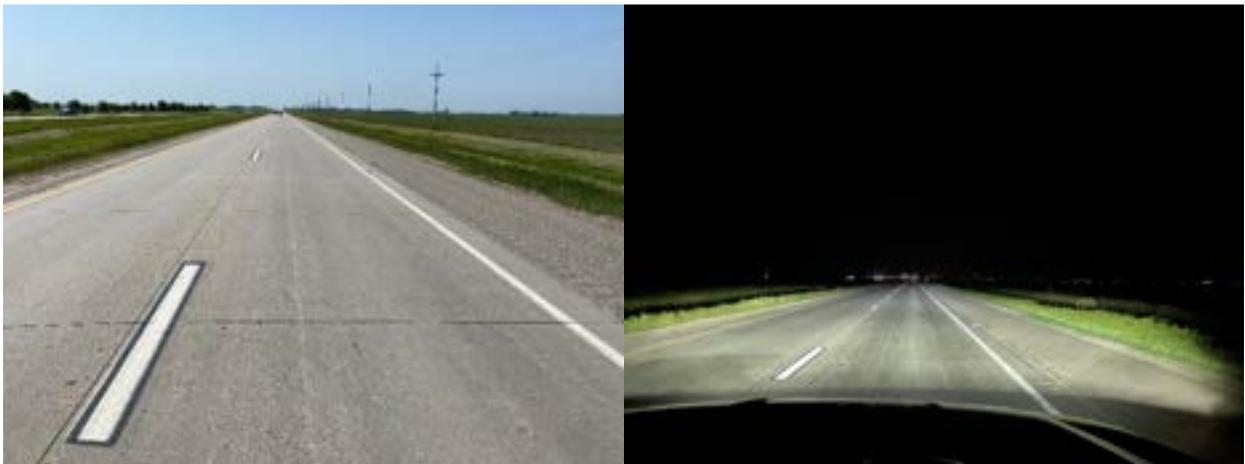
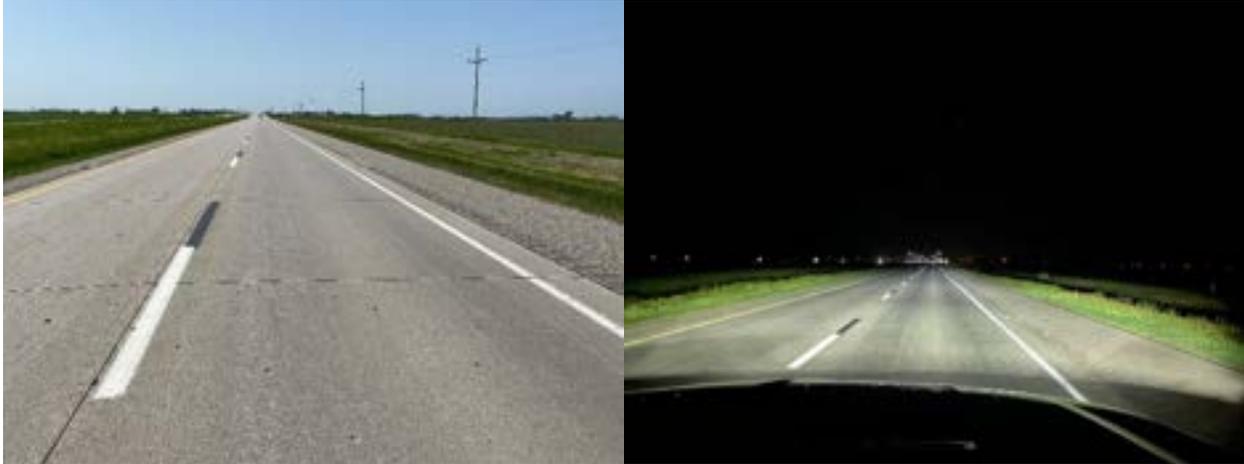
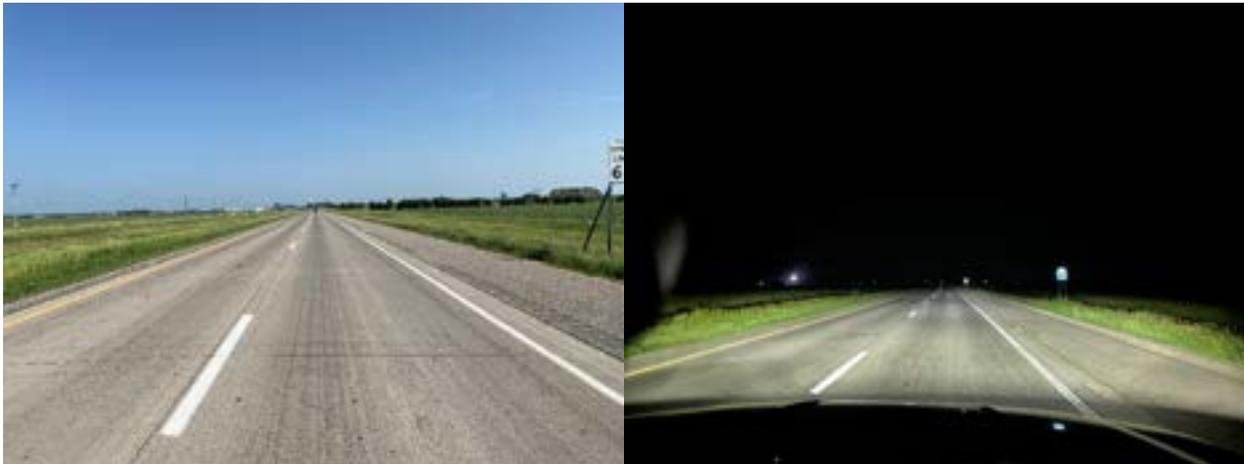
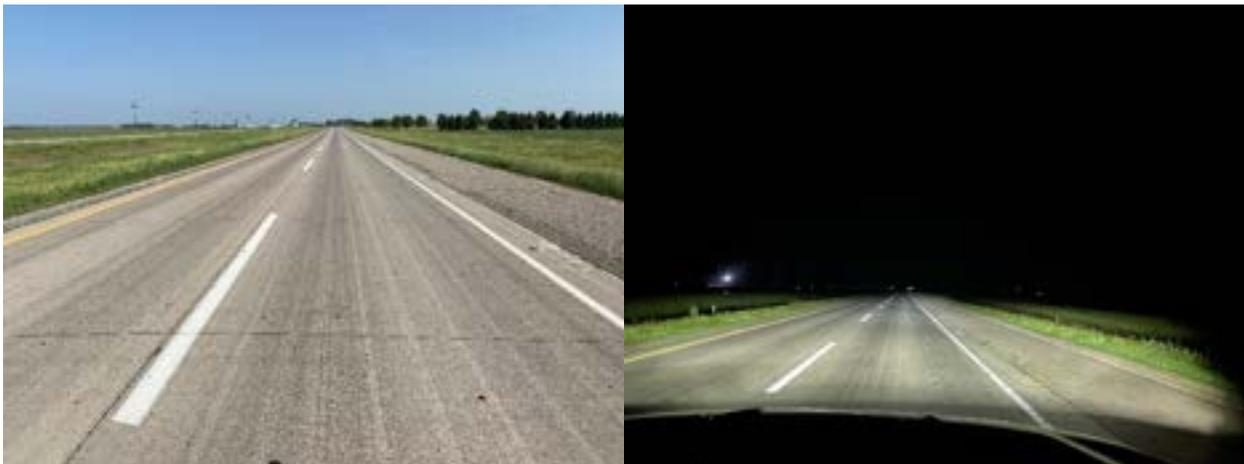
Figure 9. Segment 1 SB day (left) and night (right) images.

Figure 10. Segment 2 SB day (left) and night (right) images.

Figure 11. Segment 3 SB day (left) and night (right) images.

Figure 12. Segment 4 SB day (left) and night (right) images.

Figure 13. Segment 1 NB day (left) and night (right) images.

Figure 14. Segment 2 NB day (left) and night (right) images.

Figure 9 through Figure 19 show images of the pavement markings at the different test areas during the day and at night. The research team was able to capture images while stationary on MN 336, whereas on I-94 the images were captured at highway speed.

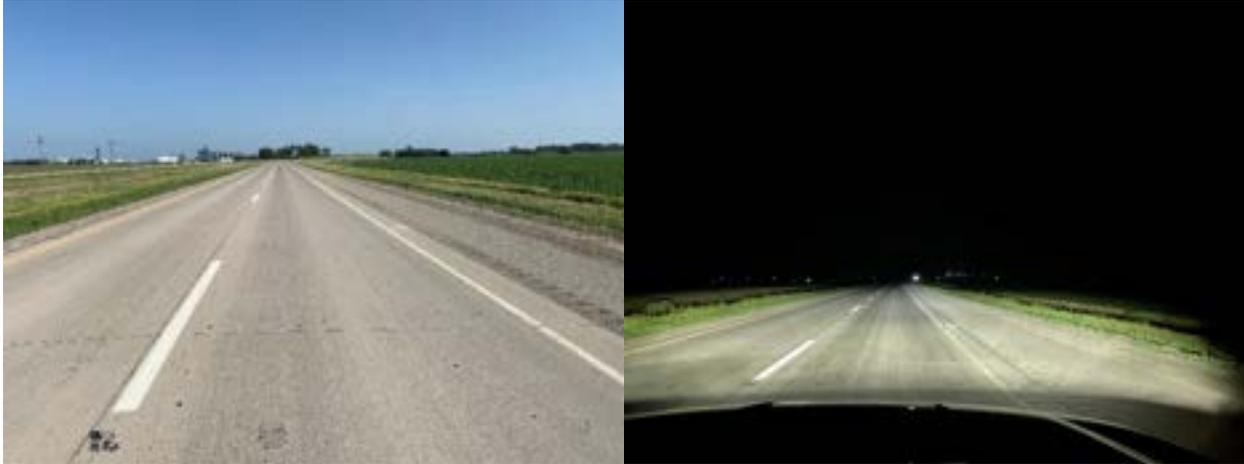
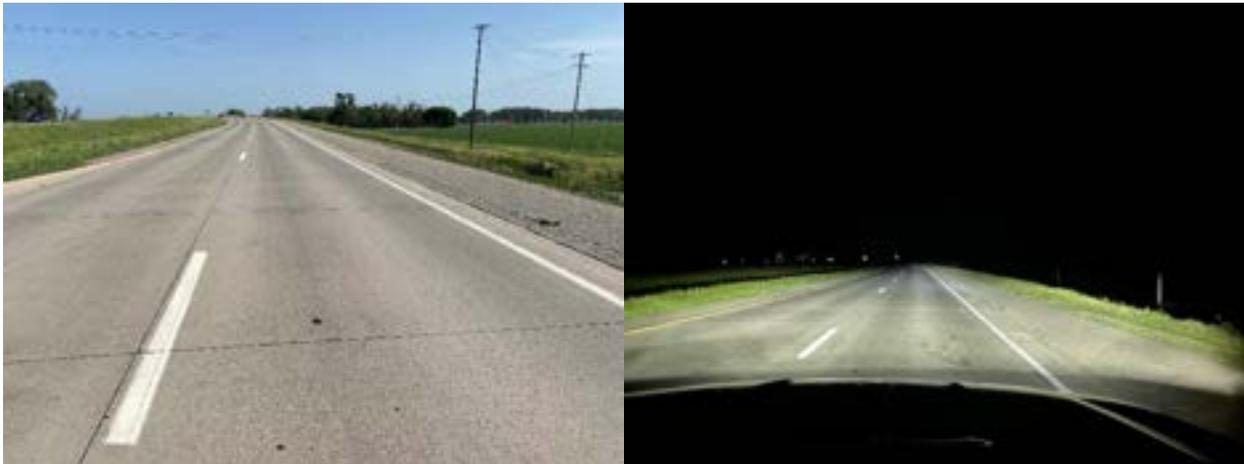
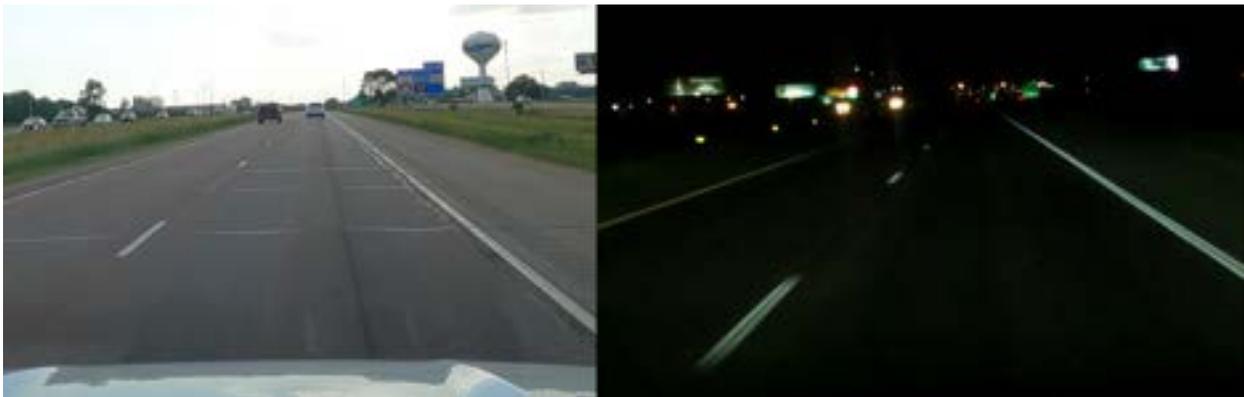
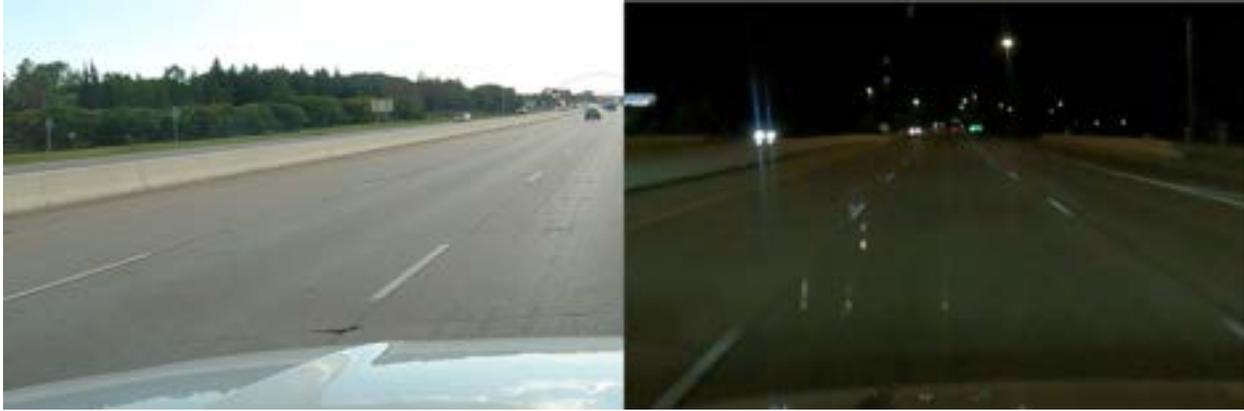
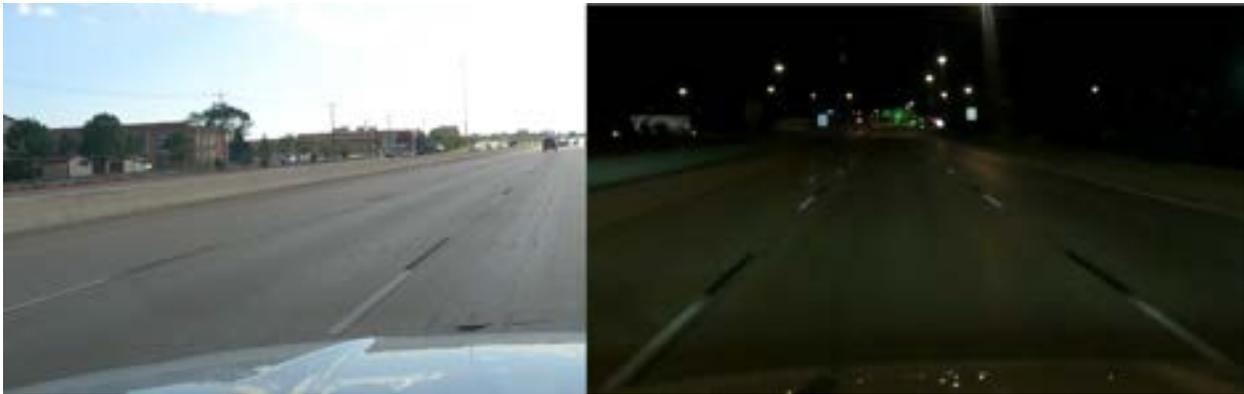
Figure 15. Segment 3 NB day (left) and night (right) images.

Figure 16. Segment 4 NB day (left) and night (right) images.

Figure 17. I-94 WB1 day (left) and night (right) images.

Figure 18. I-94 WB2 day (left) and night (right) images.

Figure 19. I-94 WB3 day (left) and night (right) images.

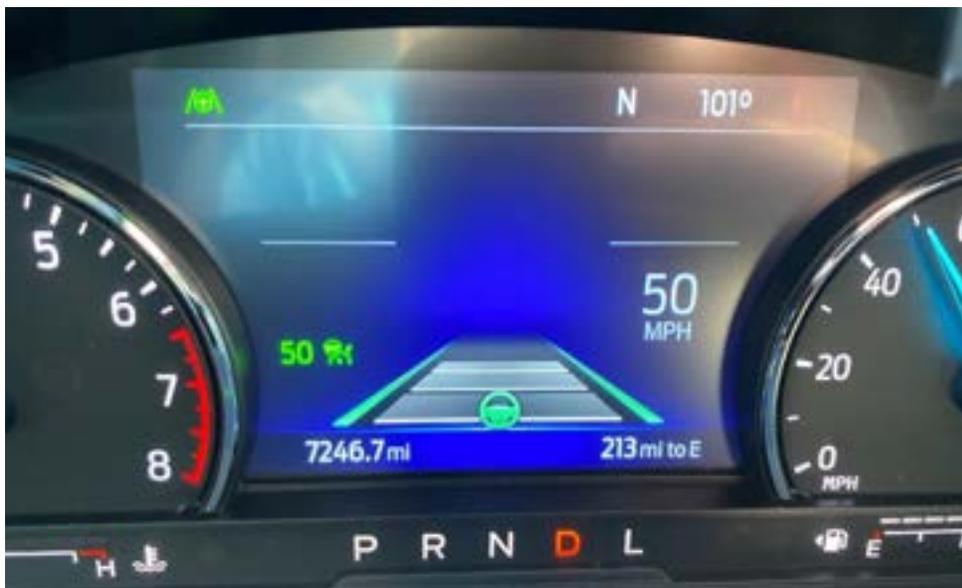
Figure 22. Ford Co-Pilot 360 Assist+ gauge cluster.

The research team used a 2022 Ford Explorer with a Co-Pilot 360 Assist+ system to evaluate the markings. Figure 20 shows the OEM camera used for the Co-Pilot 360 Assist+ system. The Co-Pilot 360 Assist+ system provides lane centering capability when the system is active and the markings are able to be tracked. The vehicle operator maintained a light touch on the steering wheel to keep the system active but allowed the vehicle to provide the steering during testing. The research team used two GoPro cameras to record the forward scene and the instrument cluster. The instrument cluster indicated when the system was active and if lane centering functions were working. Figure 22 shows the instrument cluster with the Co-Pilot 360 Assist+ system active and tracking the markings. The system is active and tracking the markings when the lines are green. The lines are gray when it is not tracking.

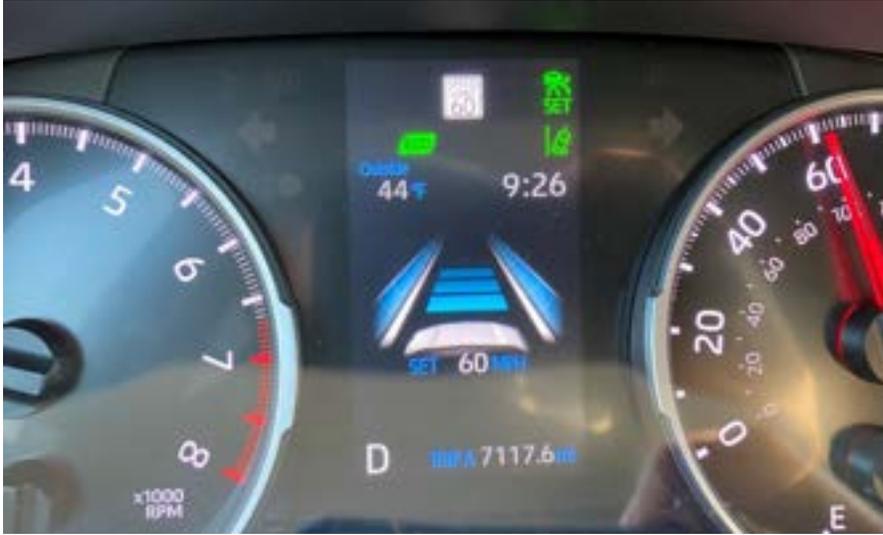
Figure 26. Toyota TSS 2.0 gauge cluster.

The research team used a 2022 Toyota RAV4 to evaluate most of the pavement marking test areas. The RAV4 uses a single forward-facing camera like the 4Runner described in the next section. The evaluated system provides lane centering driver assistance when the system is active. Figure 26 provides an image of the RAV4 instrument gauge cluster. The lane centering feature is active when both the white bars and blue bars are indicated as is displayed in Figure 26. If the blue bars are not present, then lane centering is not functioning. If only the white bars are present, then the system will only provide lane keeping assistance. If neither the white or blue bars are present then the system is not providing any steering assistance. The vehicle operator maintained a light touch on the steering wheel to keep the system active but allowed the vehicle to provide the steering during testing. An interior video camera was used to monitor the vehicle steering as it proceeded through the test areas.

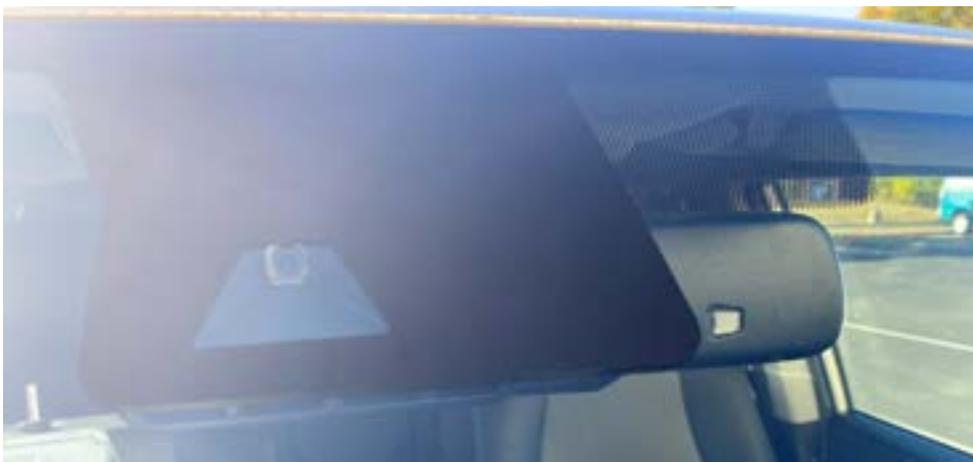
Figure 27. Toyota forward facing camera.

The research team used a 2022 Toyota 4Runner to evaluate most of the pavement marking test areas. The 4Runner has a lower level of ADAS compared to other test vehicles. The 4Runner uses a single forward-facing camera as displayed in Figure 27. The evaluated system only provides lane departure warning when the system senses the vehicle leaving the lane. Figure 28 provides several images of the 4Runner instrument gauge cluster. The top image shows the lane departure warning system when no markings are being tracked as indicated by the empty lines. The middle image shows the system when it is tracking markings on both sides of the vehicle as indicated with the filled in white lines. The bottom image shows the system when the warning is being provided for a lane departure with the orange line. When operating the vehicle the operator maintained steering of the vehicle but allowed the vehicle to encroach on markings to test when the system would sense a lane departure. An interior video camera was used to monitor the vehicle steering as it proceeded through the test areas.

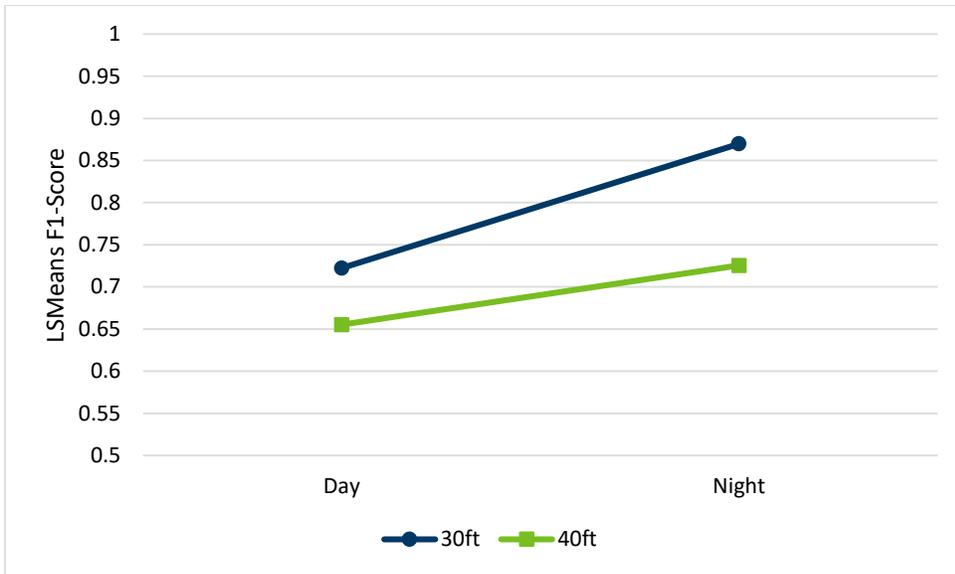
Figure 29. Effect of marking spacing and lighting condition on LD performance.

Figure 29 shows that LD performance was higher for the 10-30 configuration as compared to 10-40 configuration during both day and night. This is likely due to the fact that closer lane markings result in more marking for the LD algorithms to detect, leading to higher LD performance. Table 10 lists the least square mean value of F1 scores output for the different spacing configurations. Figure 30 and Figure 31 provide the results of the 2-way interaction of spacing and marking material for LD performance during daytime and nighttime respectively.

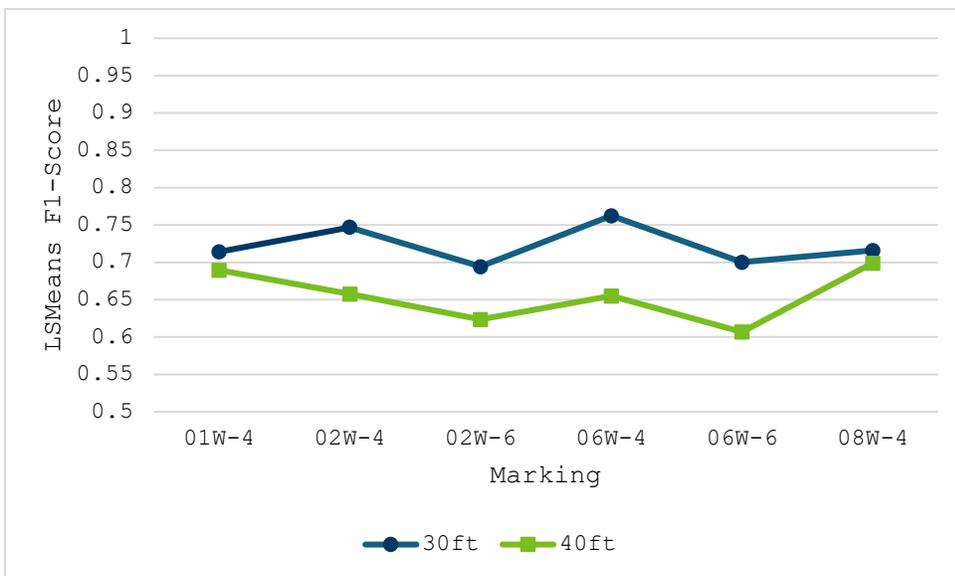
Figure 30. Effect of two-way interaction of marking spacing on marking material for daytime LD performance.

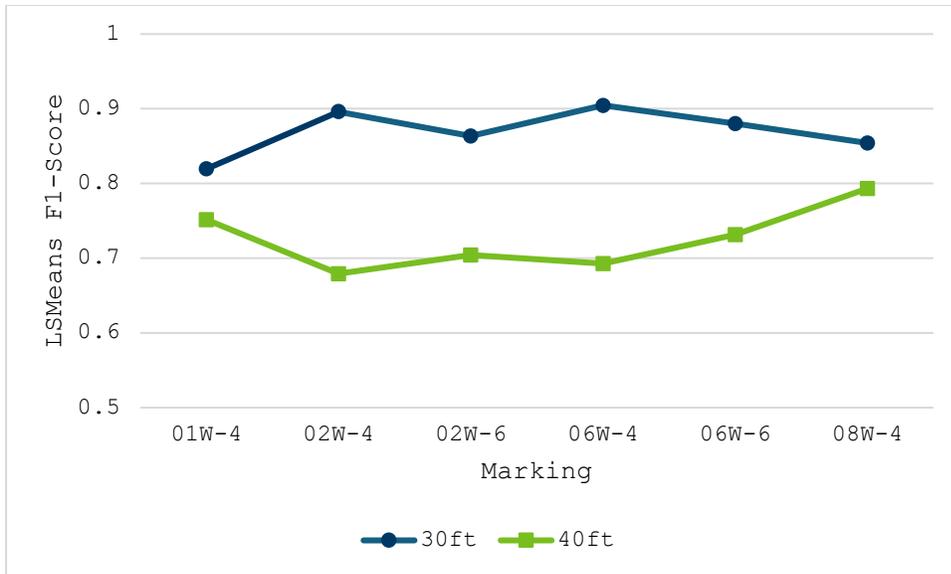
Figure 31. Effect of two-way interaction of marking spacing on marking material for nighttime LD performance.

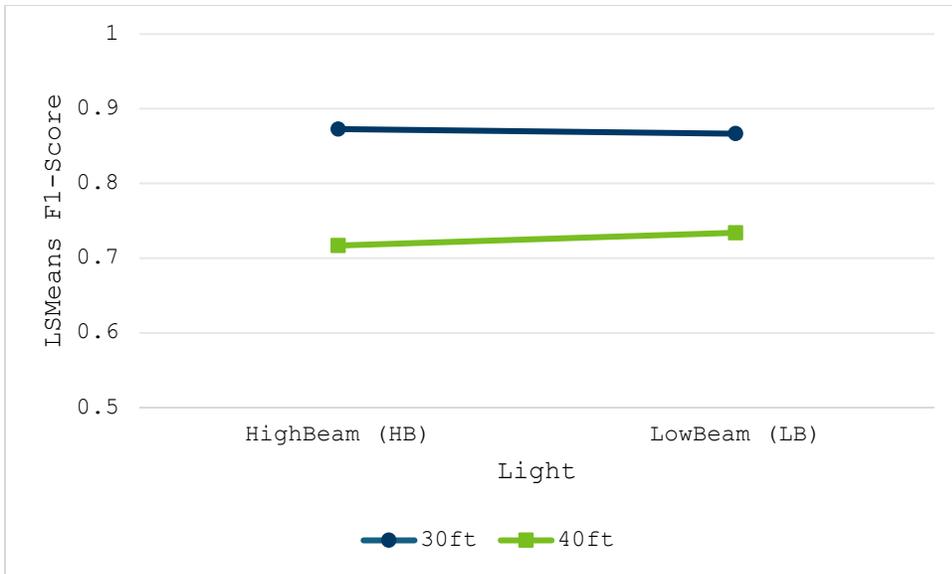
Figure 32. Effect of nighttime illumination on LD performance.

Table 11 shows the least square means table comparing the effect of nighttime illumination on LD performance. The performance difference between high and low beam is negligible.

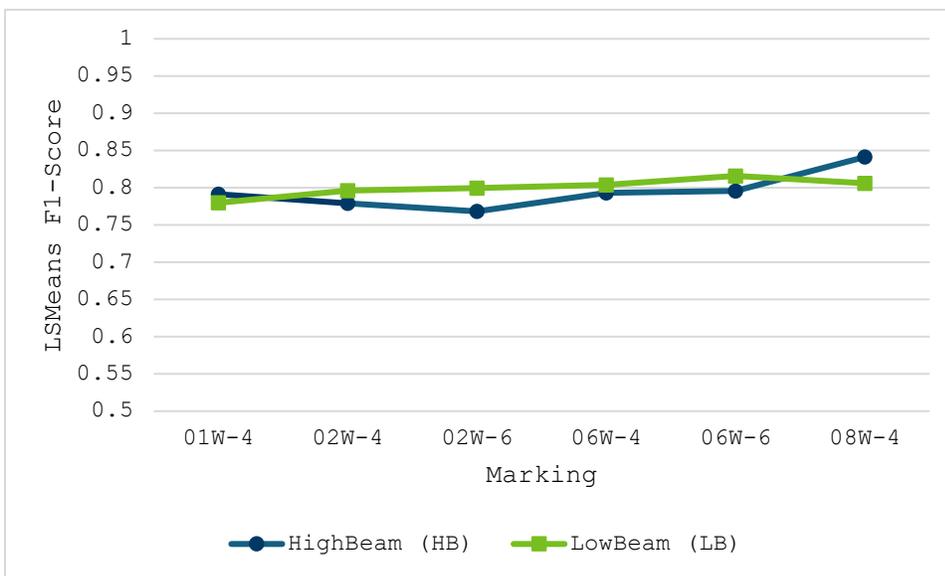
Figure 33. Effect of two-way interaction of nighttime illumination on marking material for LD performance.

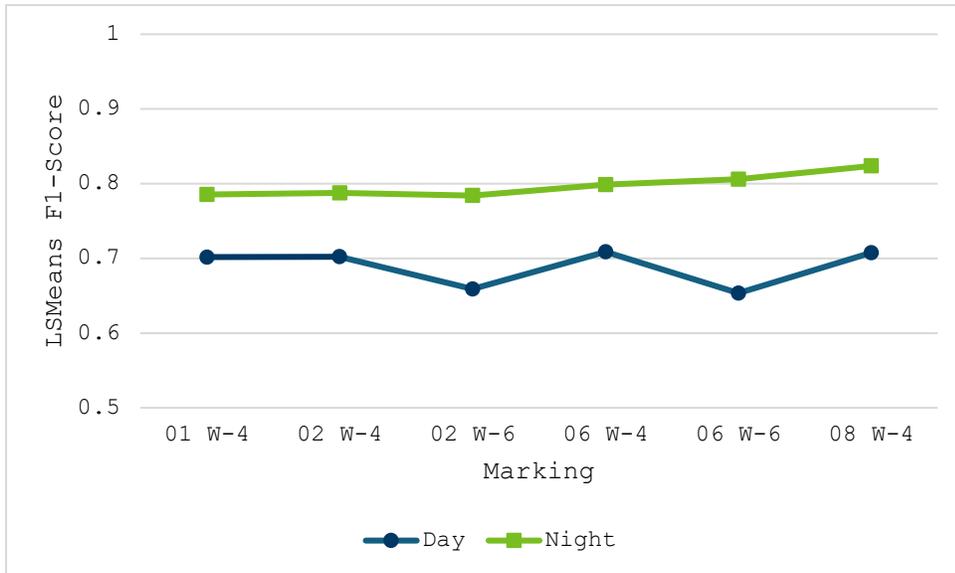
Figure 34. Effect of marking material for LD performance.

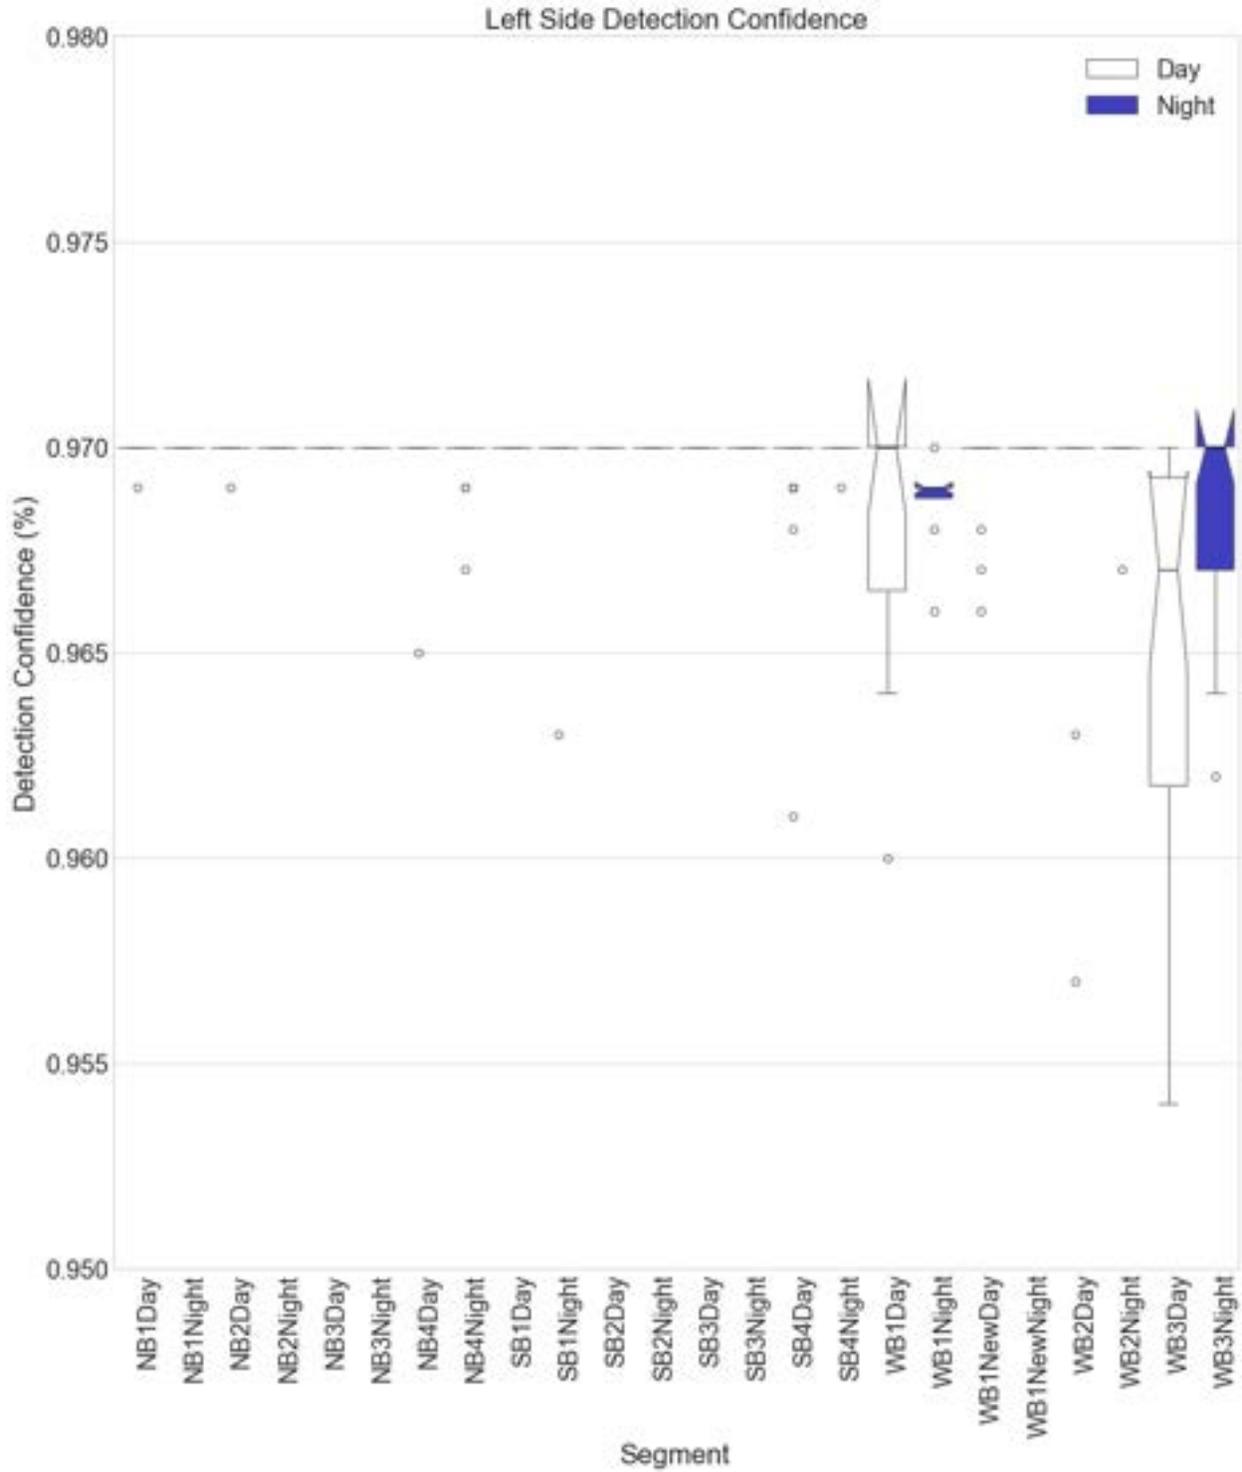
Figure 35. Left side detection confidence values in the range of (0.95, 0.98) in study segments.

Figure 35 shows the detection confidence values for the pavement marking test areas. Table 14 shows average detection distance values during the day and night. We can see that WB1 had lower values prior to restriping. The first westbound segment was restriped during the study and WB1 represents before restriping conditions while WB1New represents after restriping conditions. Pavement markings at WB1 were not very reflective and this resulted in the slightly low nighttime detection confidence value. The other WB areas had slightly lower values than the north and southbound areas on the test deck, likely due to the older markings. SB1 is notably lower than the other test deck marking results. This segment had a slight curve which resulted in the shortest tangent section. The smaller sample size may have affected the results.

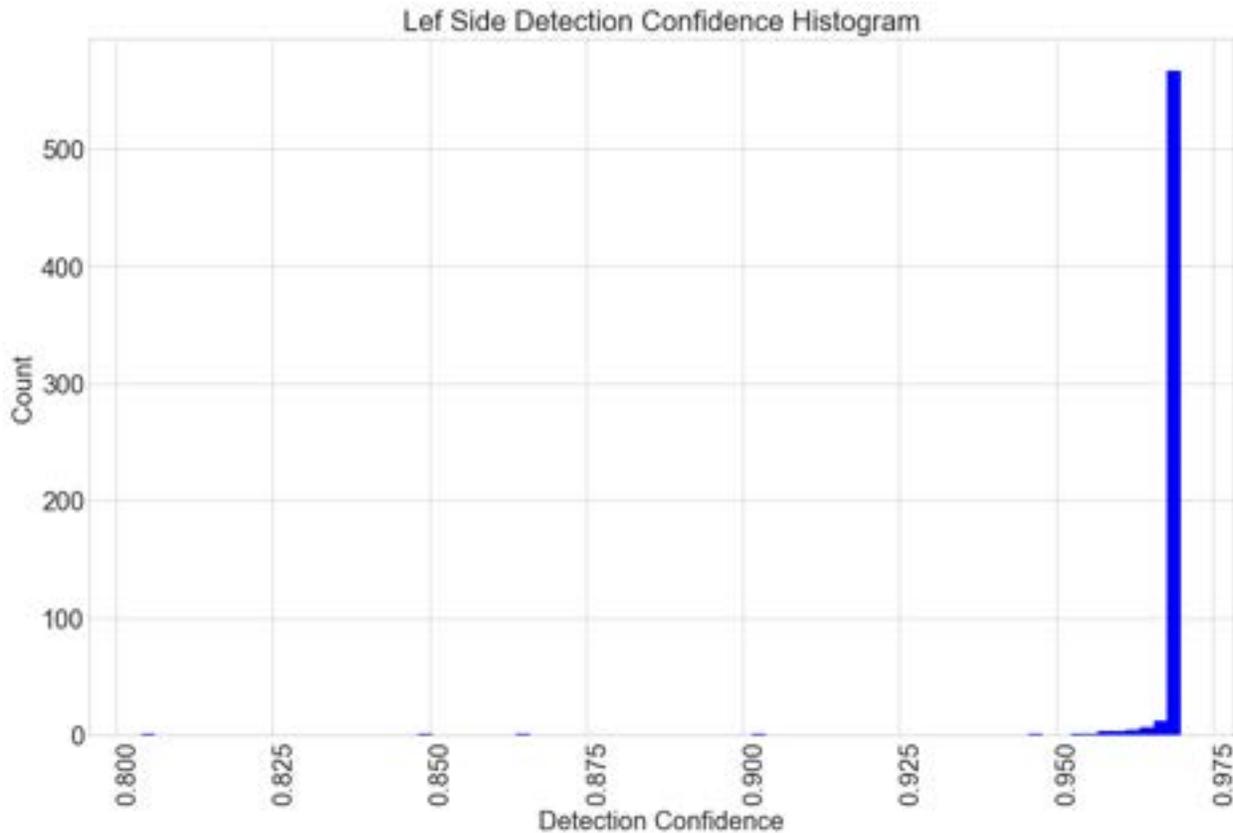
Figure 36. Left side detection confidence histogram.

The study team observed that the data for all segments were highly skewed with the majority of values being 0.96 and 0.97. Figure 36 shows the histogram of left side detection confidence values.

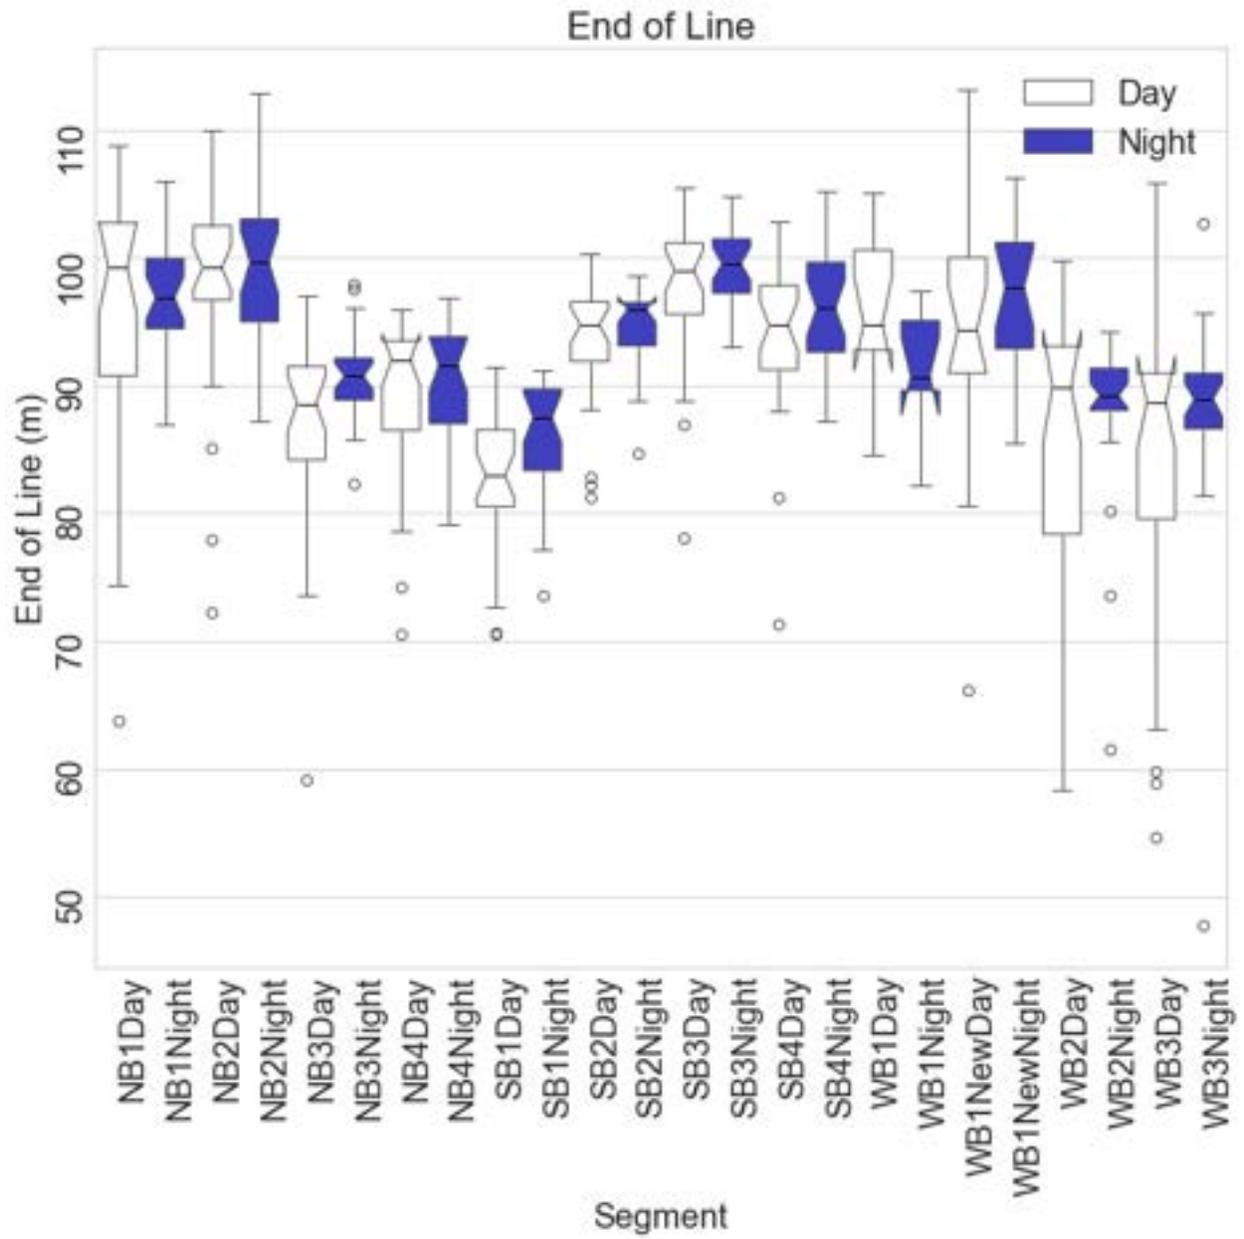
Figure 37. Left side end of line values in study segments.

In addition to detection confidence, the study team investigated the impact of the independent variables on the end of line detection distance values for the test markings. The end of line values show how far ahead the Mobileye system is capable of detecting the pavement markings and is presented in meters. Figure 37 shows a boxplot of the end of line values for day and night. Figure 38 shows a histogram of the left side end of line values.
