Assessing Pavement Markings for Automated Vehicle Readiness

June 2024

Research Project
Final Report 2024-16

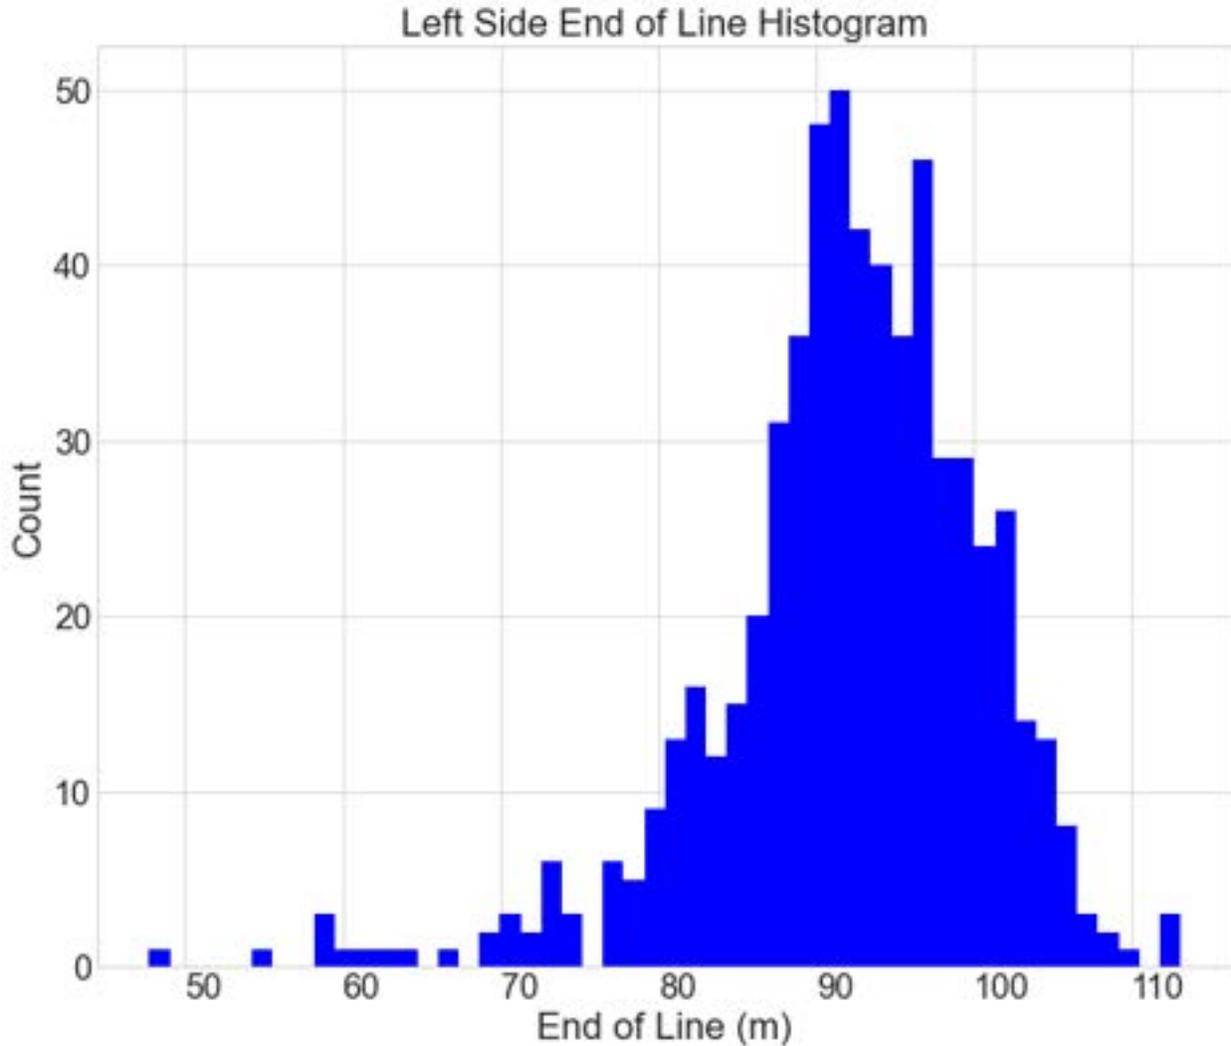
Figure 38. Left side end of line histogram.

In addition to detection confidence, the study team investigated the impact of the independent variables on the end of line detection distance values for the test markings. The end of line values show how far ahead the Mobileye system is capable of detecting the pavement markings and is presented in meters. Figure 37 shows a boxplot of the end of line values for day and night. Figure 38 shows a histogram of the left side end of line values.

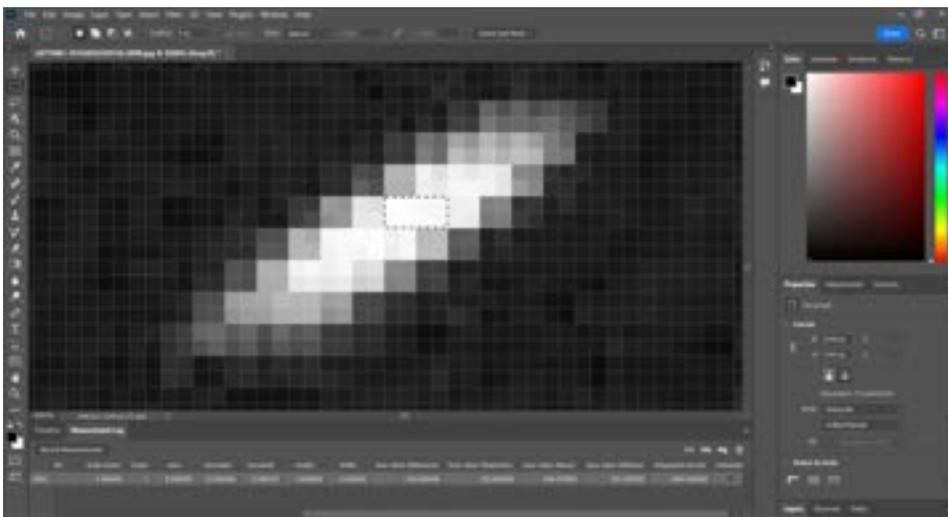
Figure 42. Zoomed image of marking being analyzed.

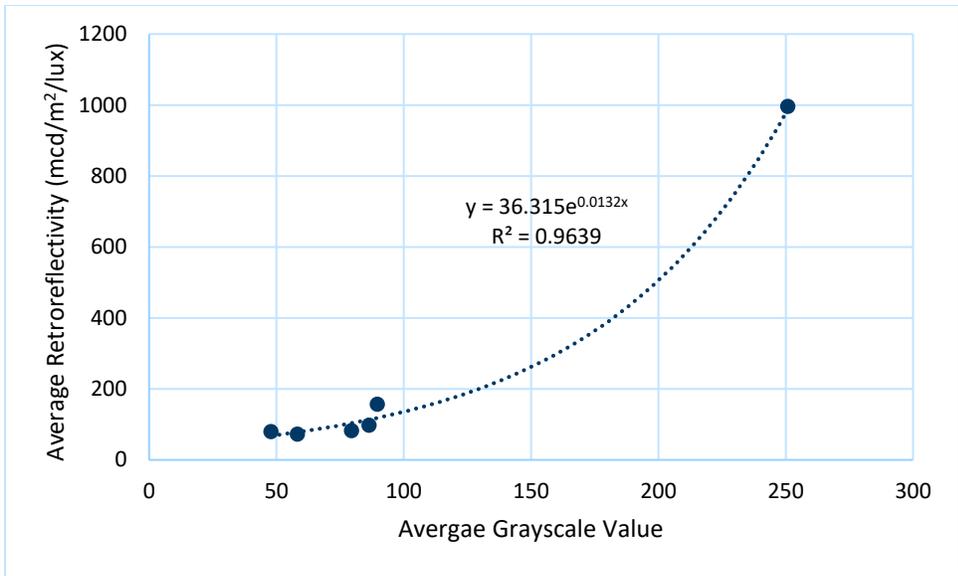
Figure 77. Grayscale value vs measured retroreflectivity.

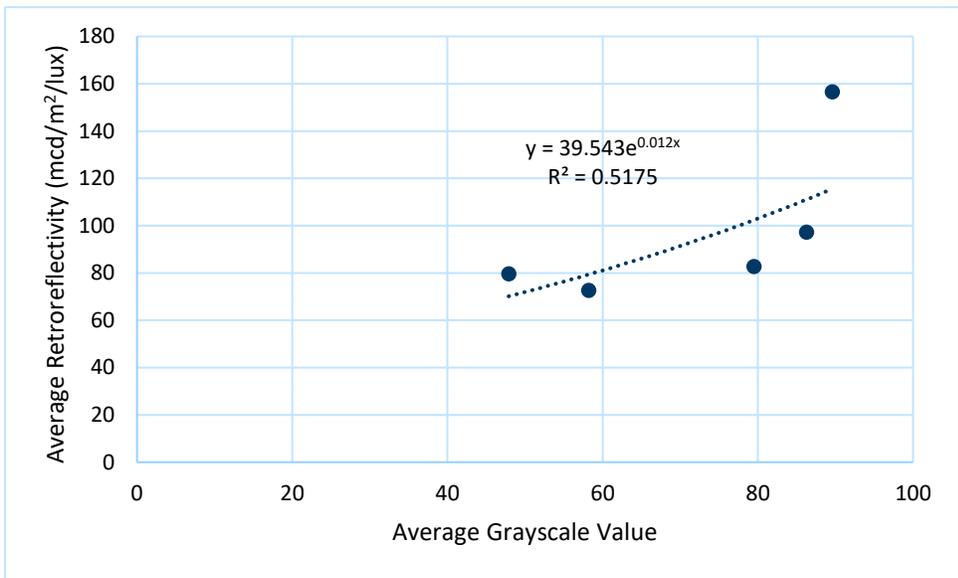
Figure 78. Grayscale value vs measured retroreflectivity (reduced).

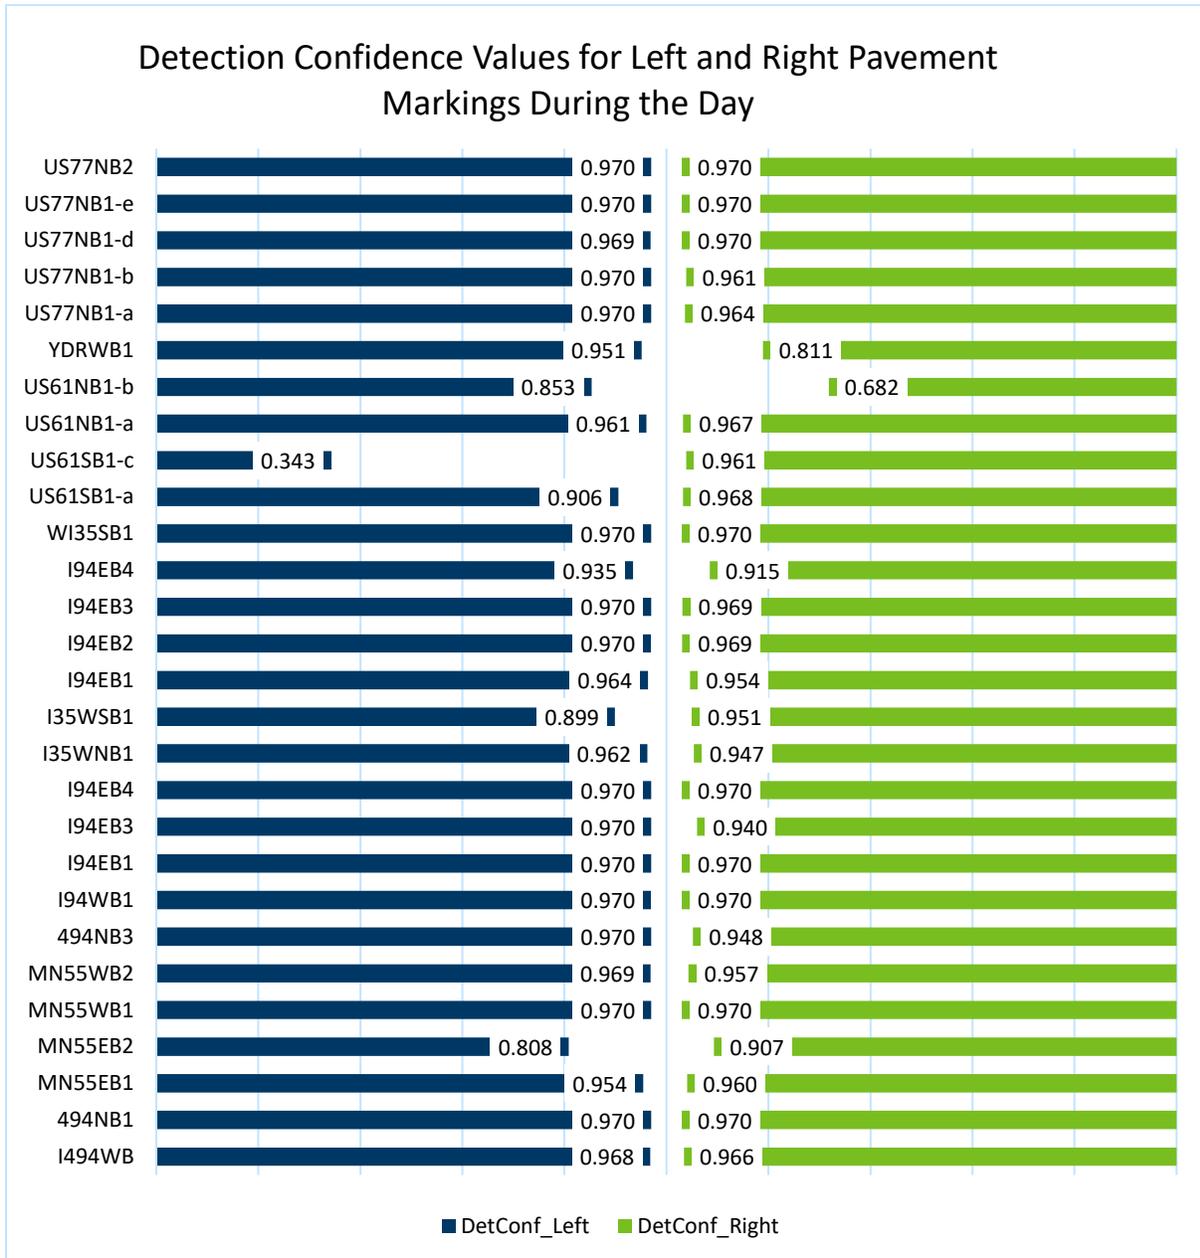
Figure 79. Detection confidence values for left and right pavement markings during the day.

of the driving lane. The study team added a new variable “Side” and re-arranged the database such that one datapoint for each side of the study segment was considered. End of line is the farthest distance (in meters) from the Mobileye camera that the Mobileye system is tracking the pavement marking. End of line is important because higher quality visibility conditions (a factor of contrast, pavement marking quality, lighting conditions, roadway geometry, etc.) should result in larger end of line detection distance values. Figure 79 through Figure 82 display the day and night detection confidence and end of line values.

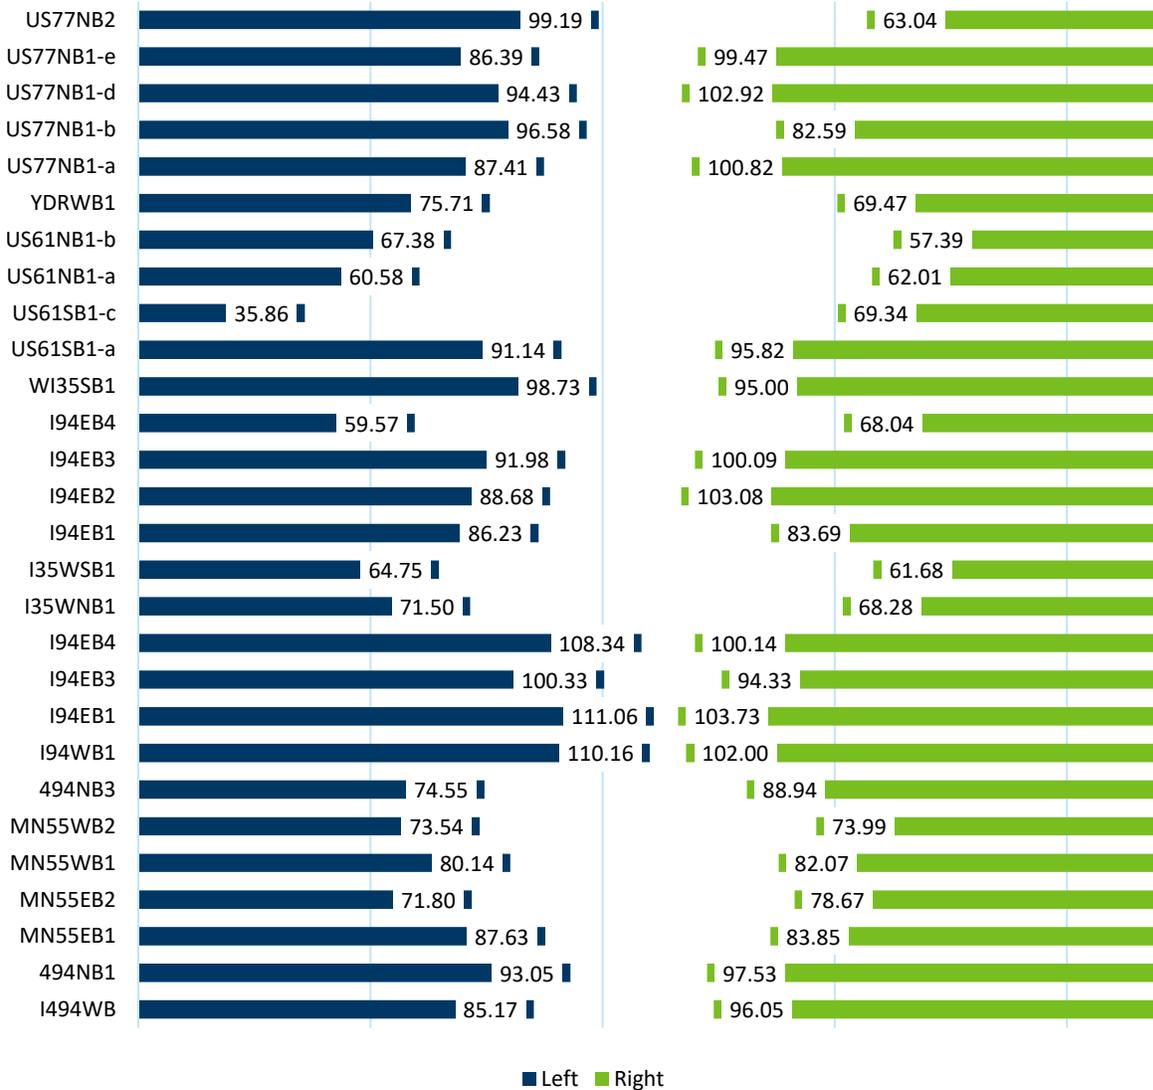
Figure 80. End of line values for left and right pavement markings during the day.

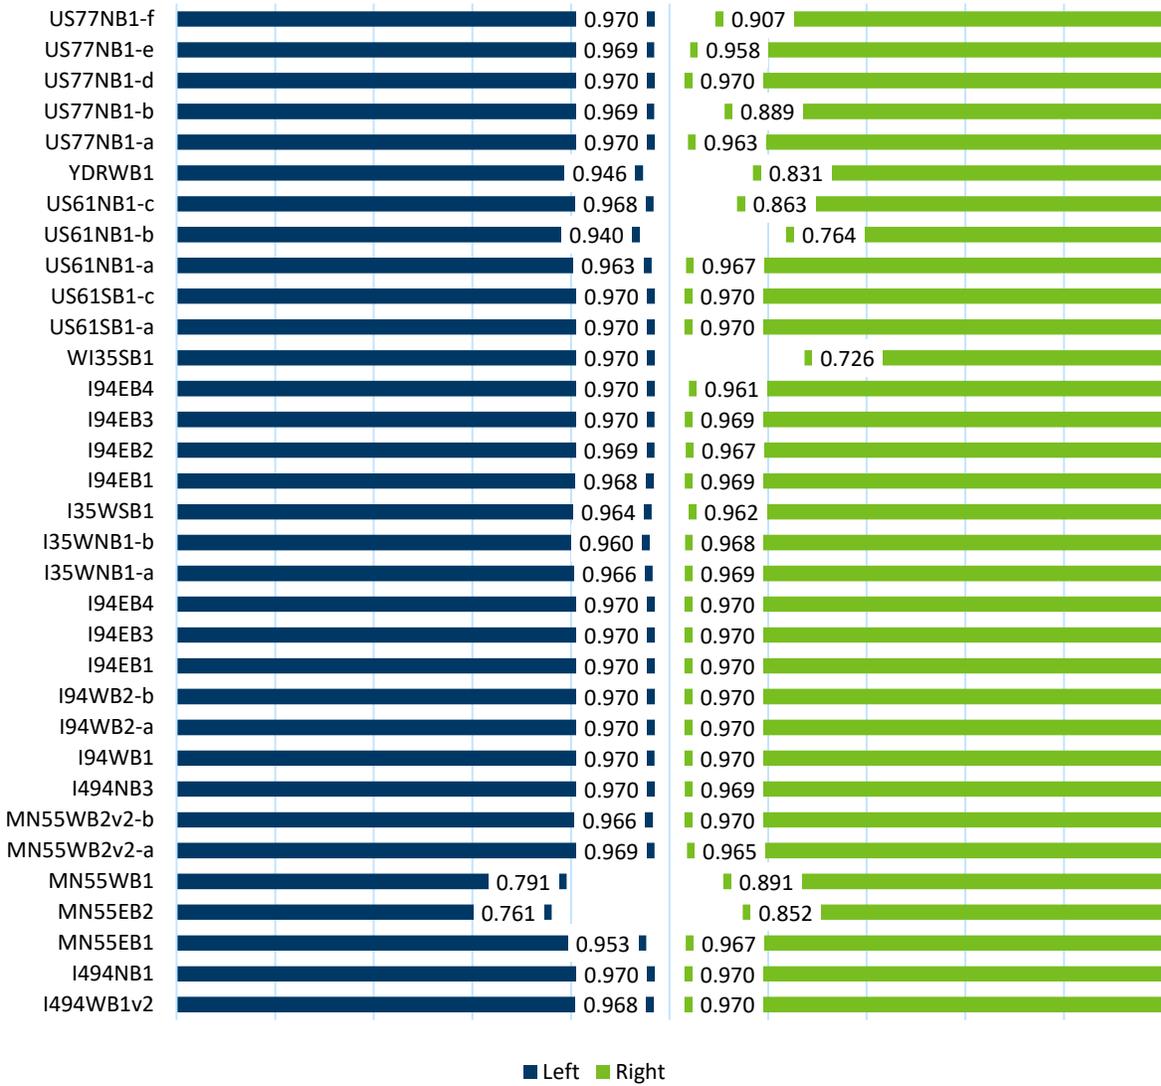
Figure 81. Detection confidence values for left and right pavement markings during the night.

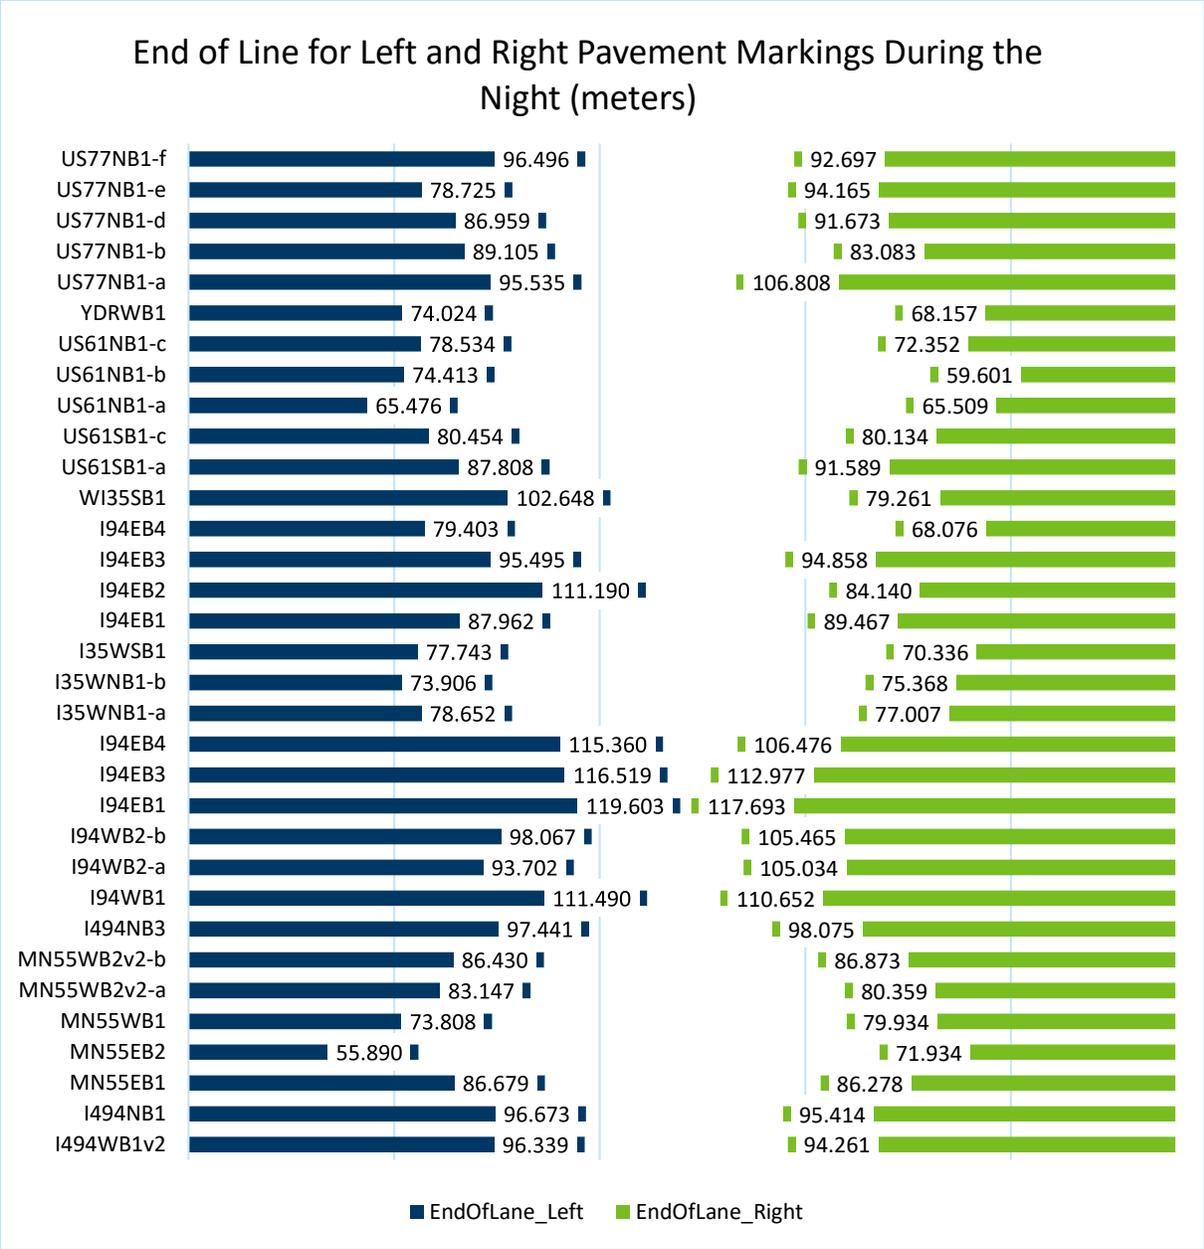
Figure 82. End of line values for left and right pavement markings during the night.

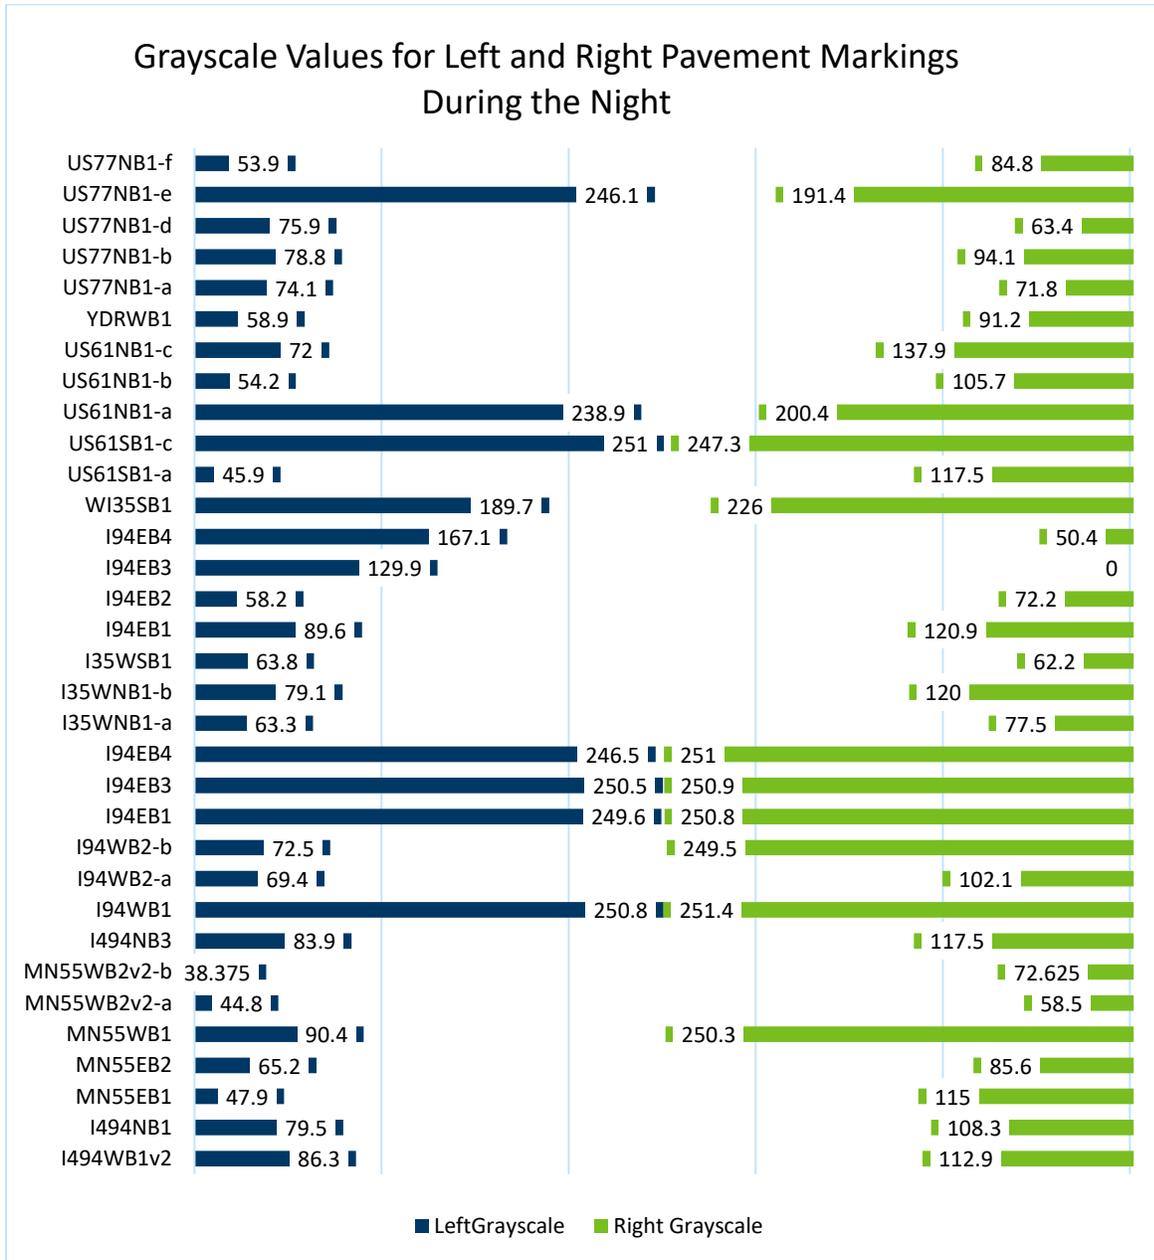
Figure 83. Grayscale values for left and right pavement markings during the night.

Table 27 and fit statistics of the model are shown in Table 28. We can see that Grayscale is not a significant variable to predict detection confidence. This is likely due to the majority of the sections having high detection confidence regardless of the grayscale value.

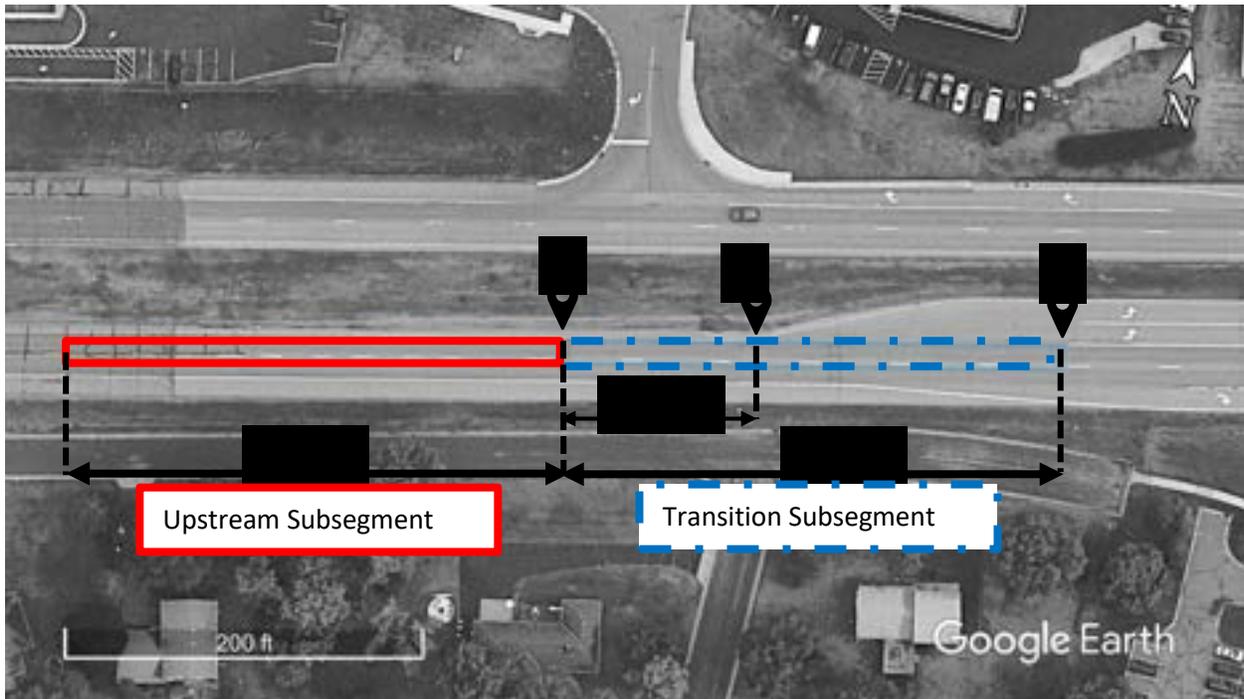
Figure 85. Transition subsegment and upstream subsegment selection process.

- c- The distance from Point B to the end of transition segment (Point C) was measured. Transition subsegment is the subsegment between Point B and Point C.
- d- The upstream segment was selected immediately upstream of transition segment with equal length as transition segment.

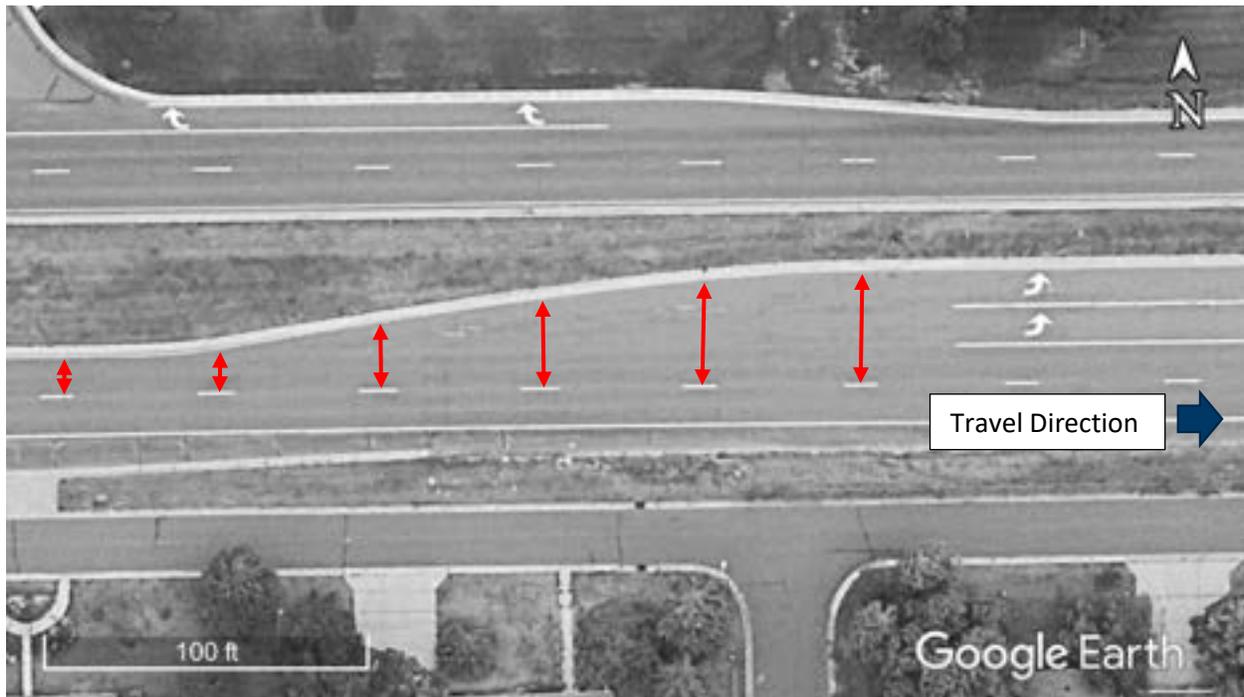
Figure 86. Increment of distance between two pavement markings at transition segments in left turn lanes.

For segments with left turn bays, the increment in lane width in the transition subsegment takes place on the left side of the road. For segments with an exit ramp on the right, the increment in lane width in the transition subsegment takes place on the right side of the vehicle. In other words, if the through lane is not marked by dotted pavement markings it seems like the lane width increases gradually. Figure 86 shows an example of this situation for left turn bays. Figure 87 shows an example of this situation for exit ramps. These two situations need to be evaluated separately and compared to sections that have dotted line extensions through the transition subsegment.

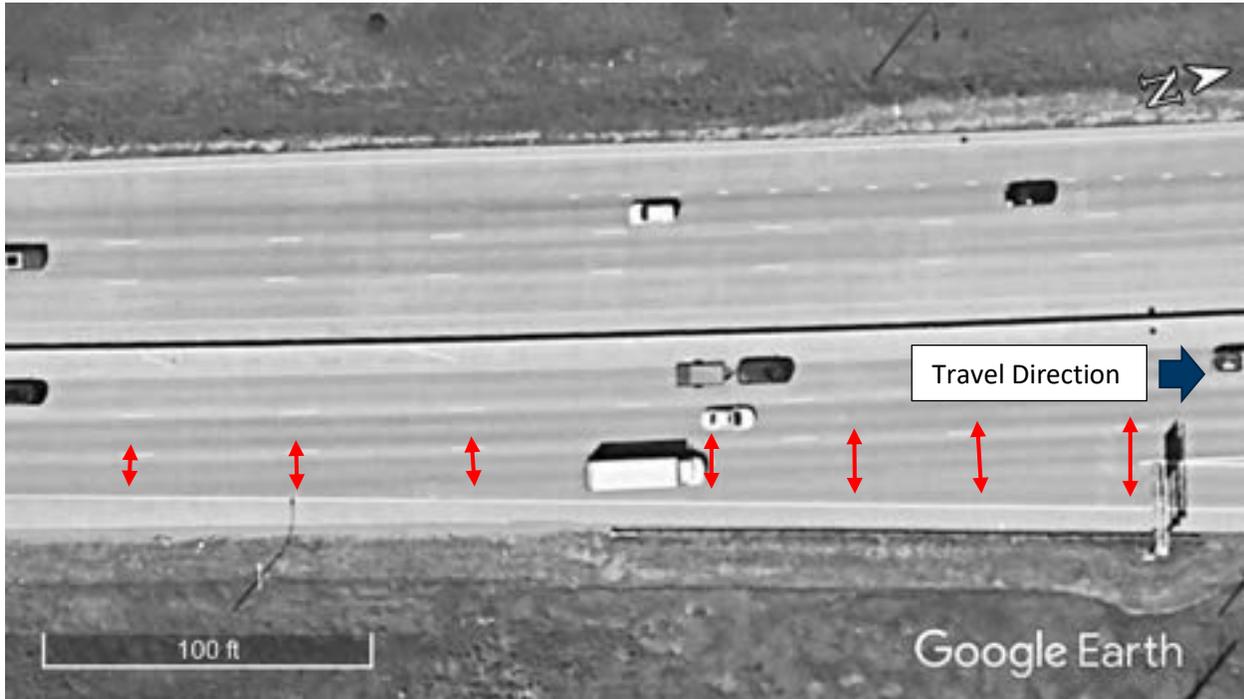
Figure 87. Increment of distance between two pavement markings at transition segments for right side off ramp study sites.

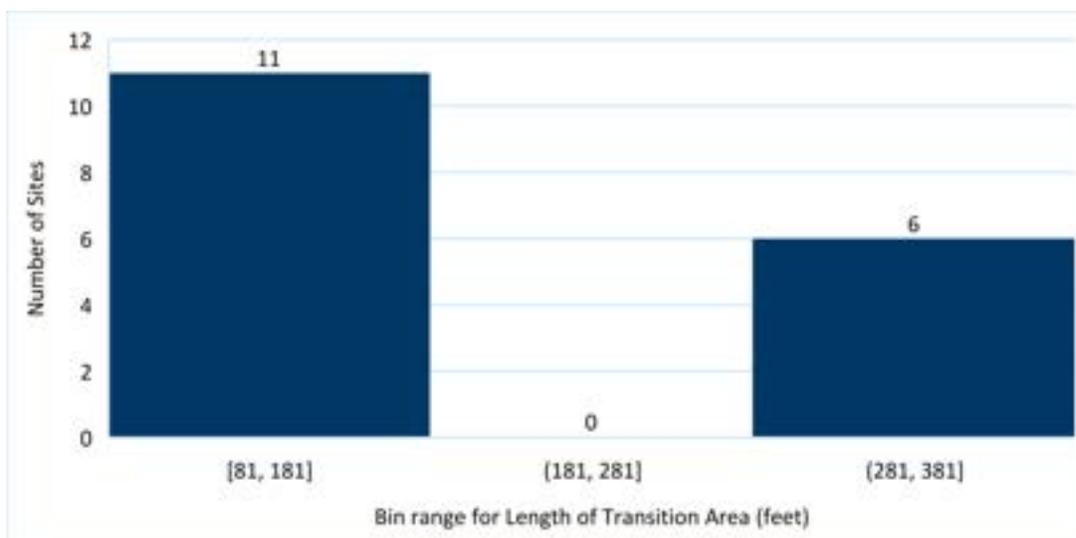
Figure 88. Transition segment length distribution for left turn lanes.

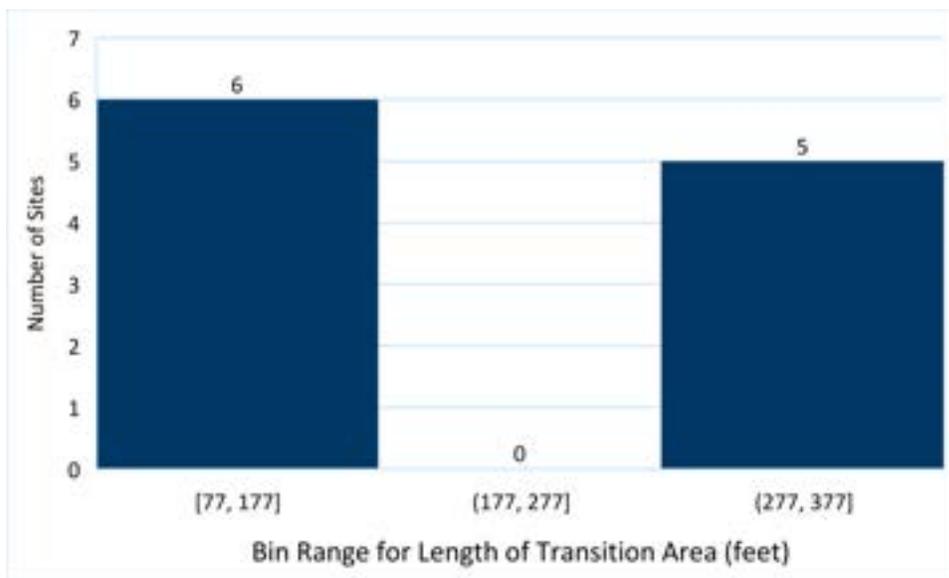
Figure 89. Transition segment length distribution for off ramp locations.
